# Stormwater Management Successes and Failures in the Prince Frederick Area

Presented to Calvert County Environmental Commission  
April 24, 2023

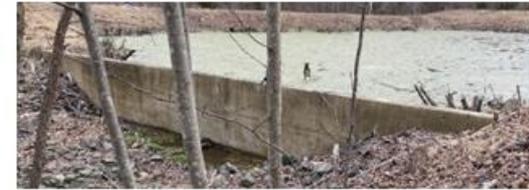
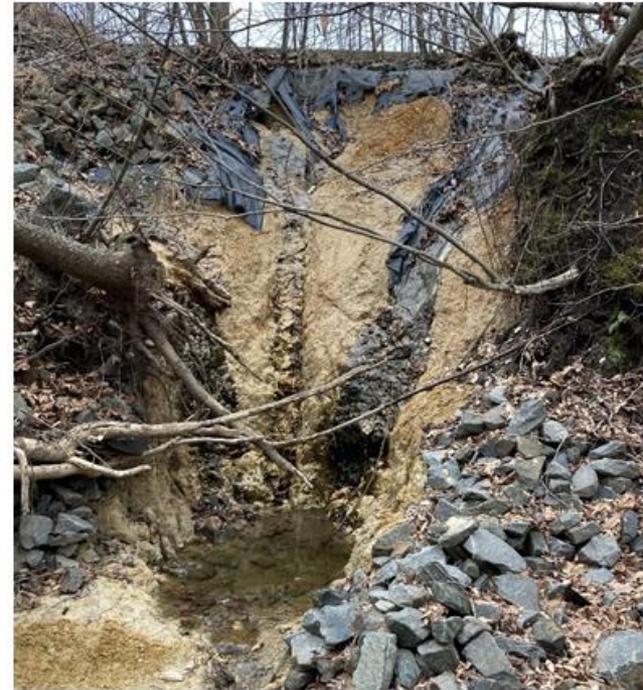
Pond 4 outlet. Designed to produce sheet flow. Land surface refocused flow.

- Just downstream of pond 4 outlet
- Eroded steep ravine. Destroyed silt barrier (black ribbons of material)
- Large sediment release into the creek

9) Pond 4 has a sheet flow exit. There are 2 problems with this approach as applied here. The sheet flow is almost immediately refocused into a stream flow and more importantly the water is then dumped onto a steep slope of fragile soil without appropriate accommodations. The pictures show the result. A large amount of sediment was conveyed into the Hunting Creek watershed and on to the Patuxent.

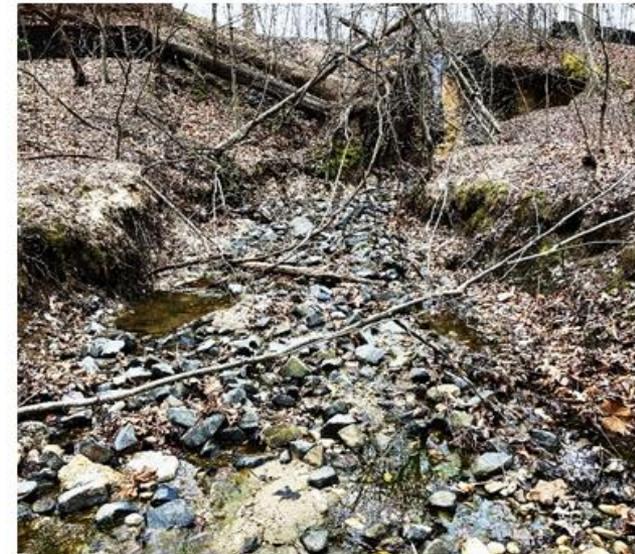
View downstream just before entrance to Fox Point Creek

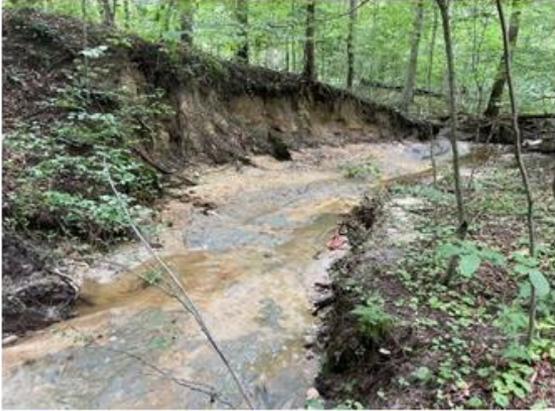
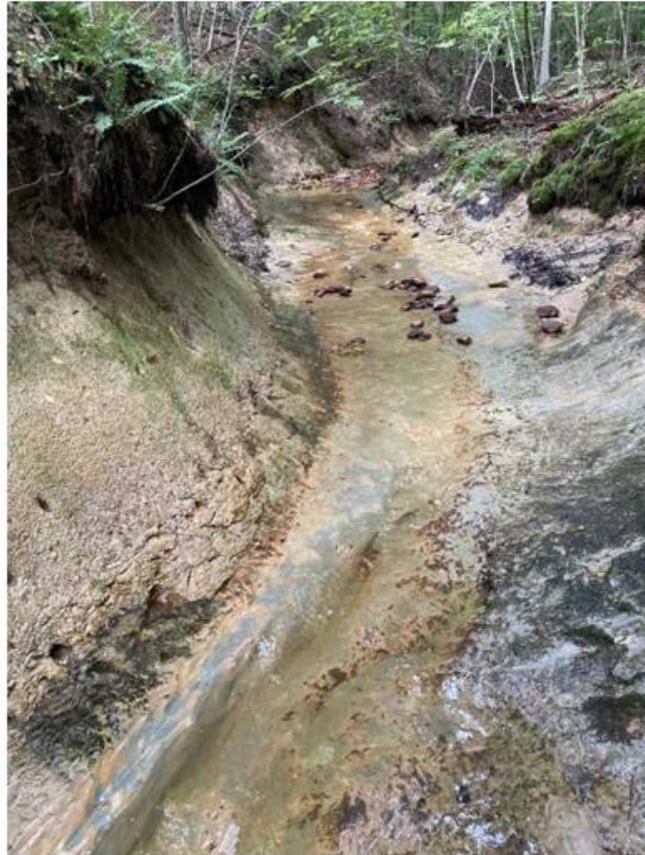
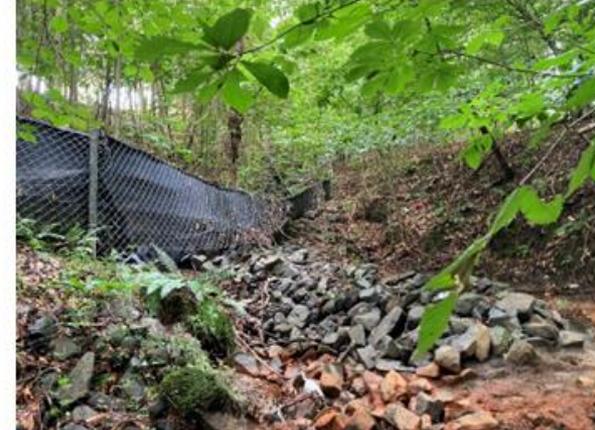
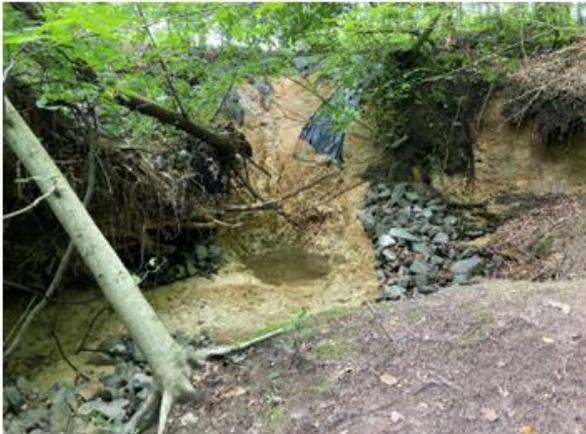
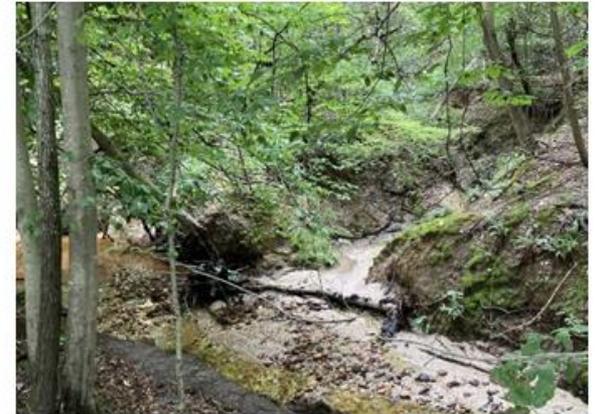
Bounded by Islamic Center, Rt 4 Stoakley and Auto Dr Properties

11) In these photos you can see a streambed incised down to the clay layer with remnants of the failed rock lined channels and silt fences.

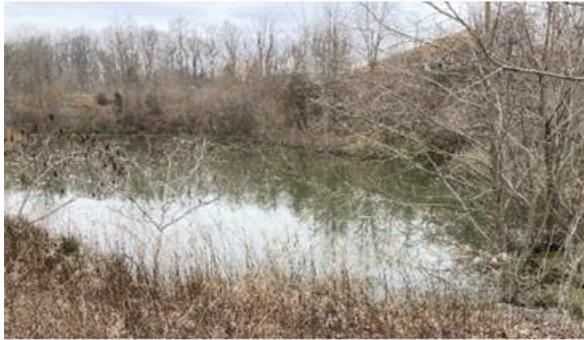
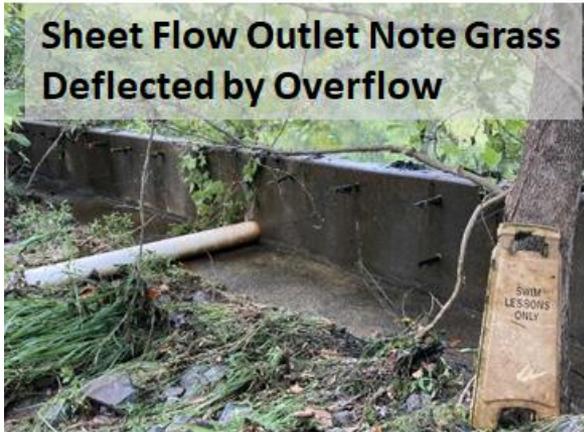
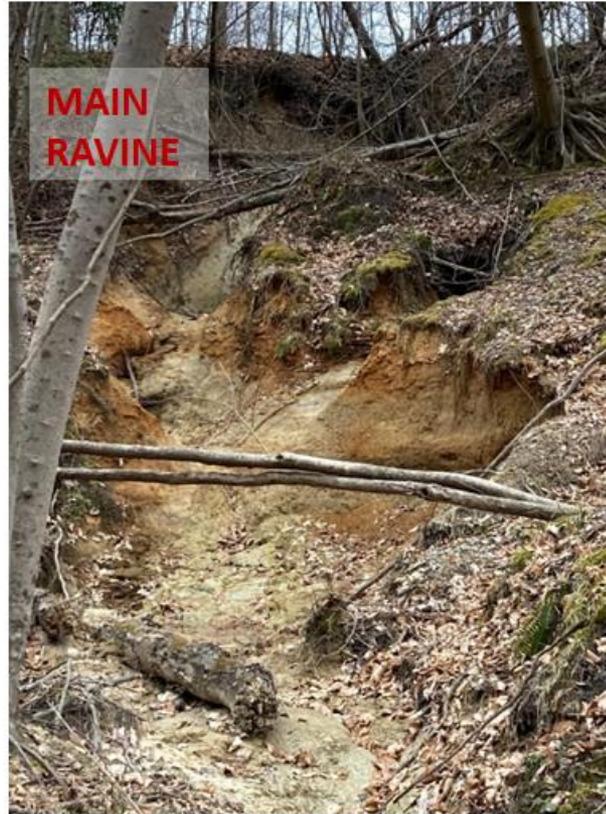
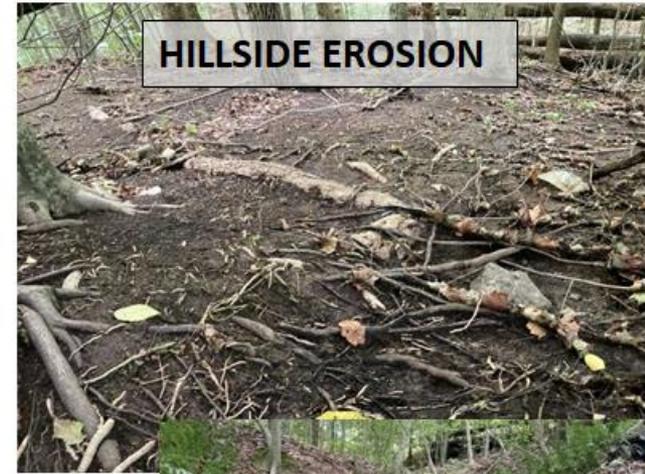
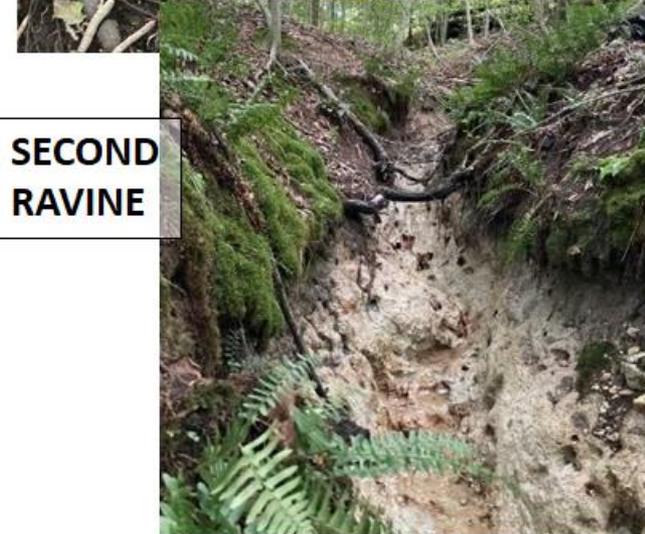
13) The exit for this pond is another sheet flow wall which divides the flow in two directions and creates two ravines. The hillside is between the two ravines and is eroding at a slower rate. Eventually the entire hillside will be eroded away. The severity of the flow over top of the wall can be seen in the deflected grass of the bottom left picture.

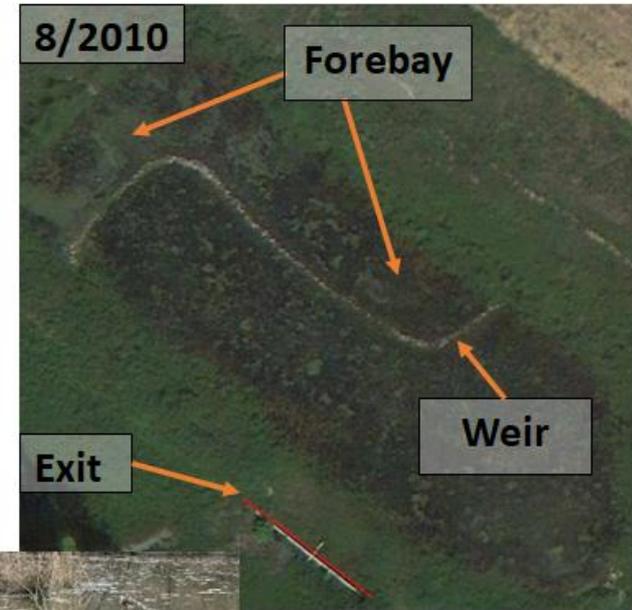
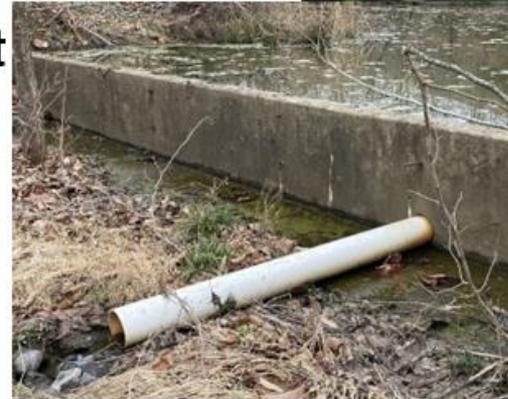
- Image Shows a Weir (Rock Wall) Early in the Life of the Pond
- Purpose
  - Separates forebay and extended storage area
  - Forebay captures most sediment
- Rarely seen → High Water in Pond
- High Water in pond Due to Sediment
- Remediation Scheduled for Out-Years in Budget
- During Wetter Times of Year Pond Routinely Overflows

14) The pool pond is actually divided into 2 parts separated by a rock weir. The Forebay at the top of the picture is supposed to capture most of the sediment. The section beyond the forebay holds most of the water for more extended periods of time. The sediment does not come from the parking lot and the hillside and pond walls are heavily vegetated. The pond overflows more frequently than it should which magnifies the erosion beyond the outflow. The excess sediment in the pond was likely deposited into the pond early in its life. Public works has outyear plans to remove sediment from the pond but .....

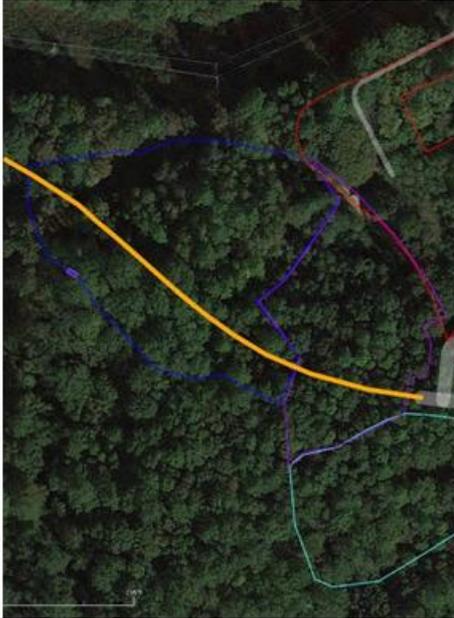
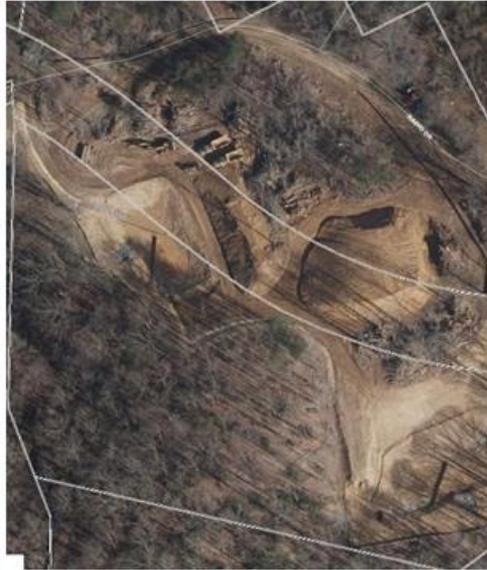
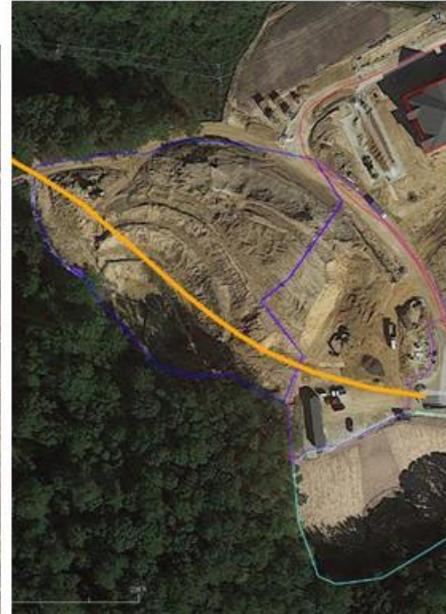
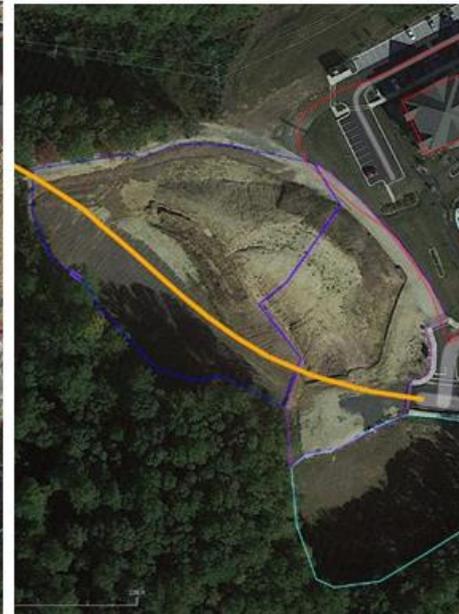
**Pre-Development Forest**  
→ **No Eroded Streambeds**

16) I will first talk about the Calvert Hills Apartments and specifically the large stockpile which is still on the property. In the 4 pictures I have retained the same outlines throughout. The October 2019 picture shows the undisturbed forest where the stockpile currently exists. From topographic maps one can see the location of pre-disturbance streams. The old streambeds were found during an onsite examination and they were NOT eroded. The erosion occurred after construction began. During the stockpiles evolution large amounts of sediment washed away. An eroded ravine formed and the streambed beyond the exit also eroded.

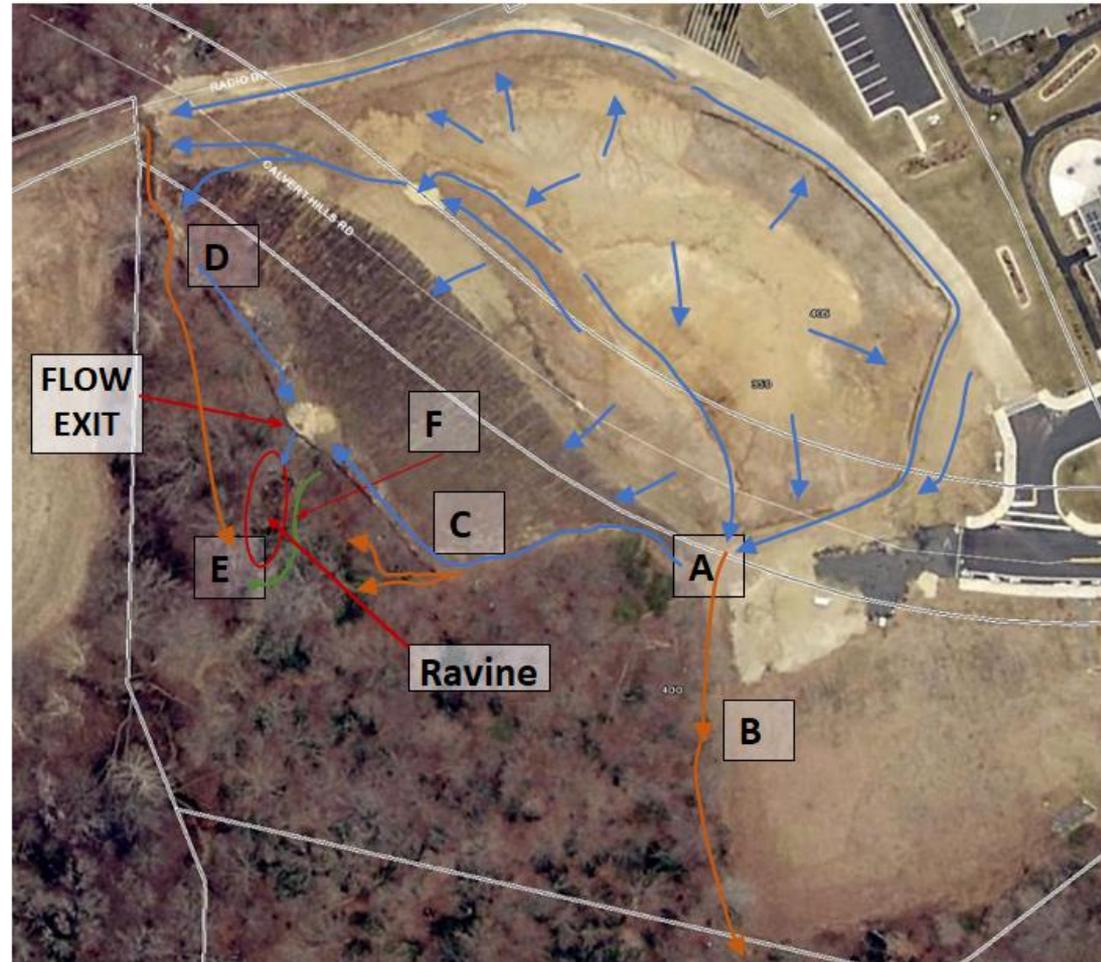
- **Original Design: All flow Through Flow Exit Shown**
- **Current**
  - 2/3 of Flow (B and E) bypasses exit
  - Bypass flow is NOT filtered through silt fences
  - Flow through ravine reduced
  - Ravine is still growing
- **Stockpile Graded Slope Was Forest → No Eroded Streambeds**

17) I've included the flow path picture here to point out some details. The actual stockpile covers 1.2 acres. The area drained including the contoured slope down to the main exit covers 2.6 acres. The stockpile only has silt fencing on the right side of the pile as seen by the dark line. Super silt fencing can be seen on both sides of the flow exit at the bottom of the contour. The original designed flow path followed C and D to the flow exit and out through the super silt fencing. This overloaded paths C and D and there was severe erosion. The current design bypasses 2/3 around the exit and flows along paths B and E. This eased the growth of the ravine and the erosion of paths C and D but NONE of the flow along B and E goes through a silt fence.

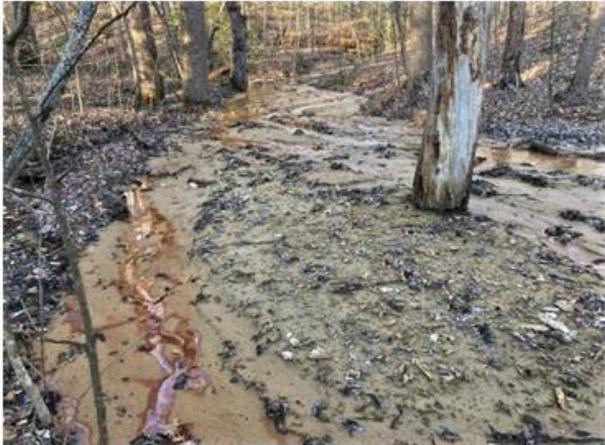
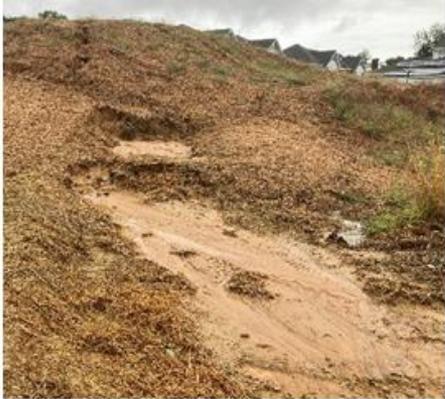
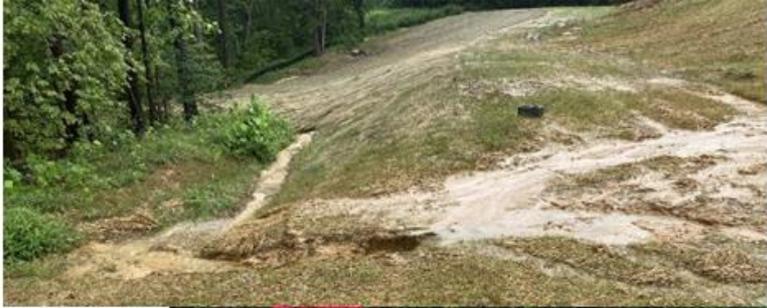
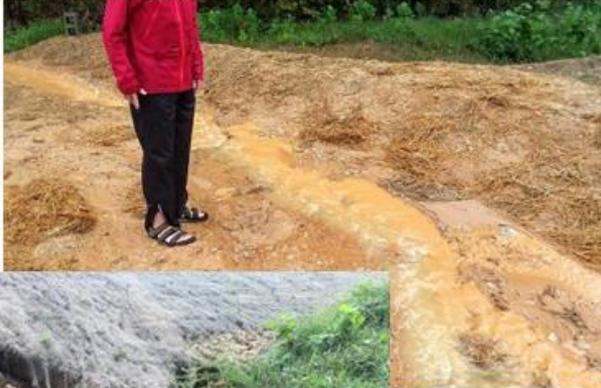
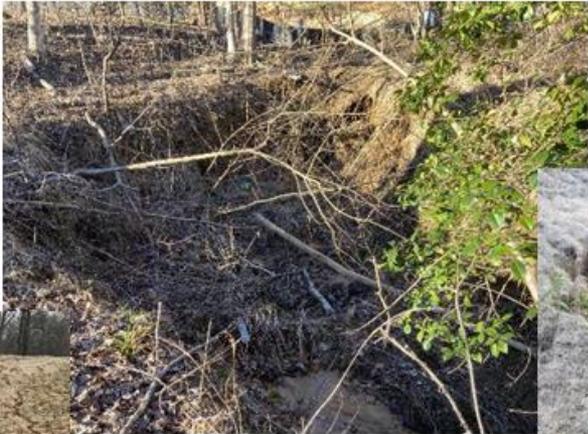
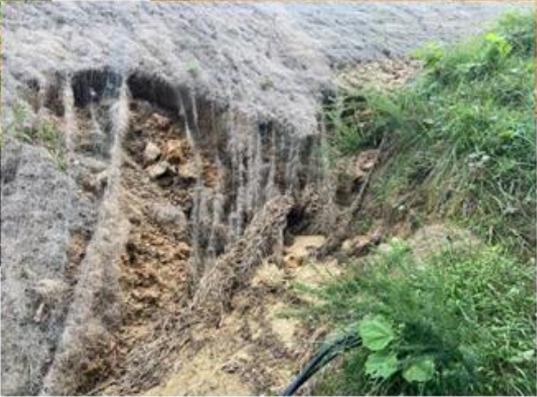
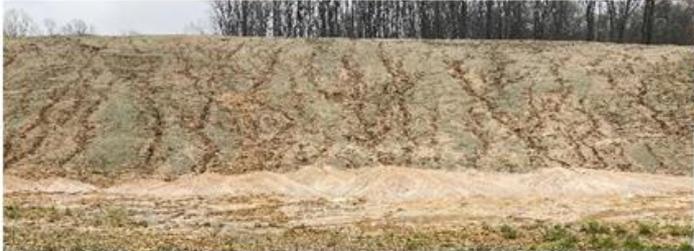
**Eroded Ravine  
Beyond Exit**

18) These are some pictures at various stages of the stockpile's evolution. The most telling is the accumulation of sediment downstream in a Mill Creek tributary. Note the dead tree. It was likely killed by the thick layer of sediment piled on top of its root area.

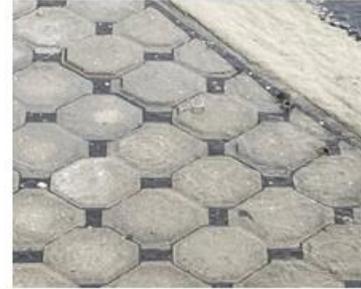
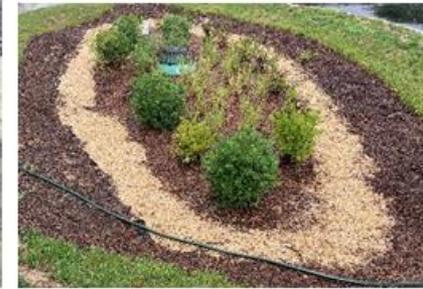
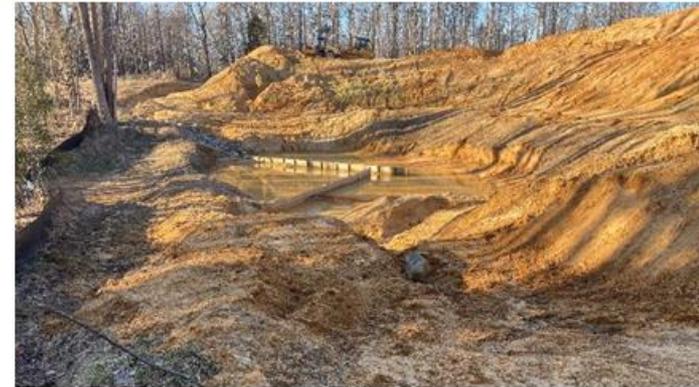
- **Apartment area has good SWM**
  - Pervious pavers
  - Extensive rain garden/micro bioretention ponds
  - Underground infiltration
- **Forested Area Cleared for Large Semi-permanent Stockpile**
- **No Site design for SWM of Stockpile**
  - Flawed SWM focuses runoff
  - Inadequate rock dams, silt fences, slope vegetation and sediment settling ponds
  - Flawed installation
- **MDE Understaffed for Prescribed Oversight**
- **Significant Ravine and Stream Incising**
- **Hundreds of Yards of Sediment Transported Into Watershed**
- **Consequences Not Consistent with Damage**

19) The apartment area has modern ESD and structural methods applied effectively. The stockpile area is another story. 3 acres of forest was stripped to make room for a significant feature which had no design details on the development's site plan. At the time the stockpile was evolving the MDE was severely understaffed and essentially no inspections were performed on the stockpile. The result was hundreds of yards of sediment being sent into the watershed. I filed a complaint with MDE during this time which resulted in renewed oversight, redirection of the design, and fines. I'm sorry to say that the consequences placed upon the developer were not consistent with the damage caused. The developer also chose to not implement a number of MDE recommendations.

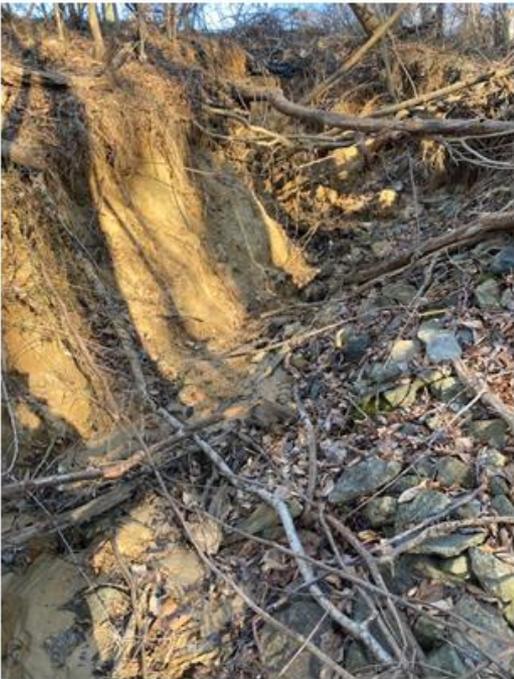
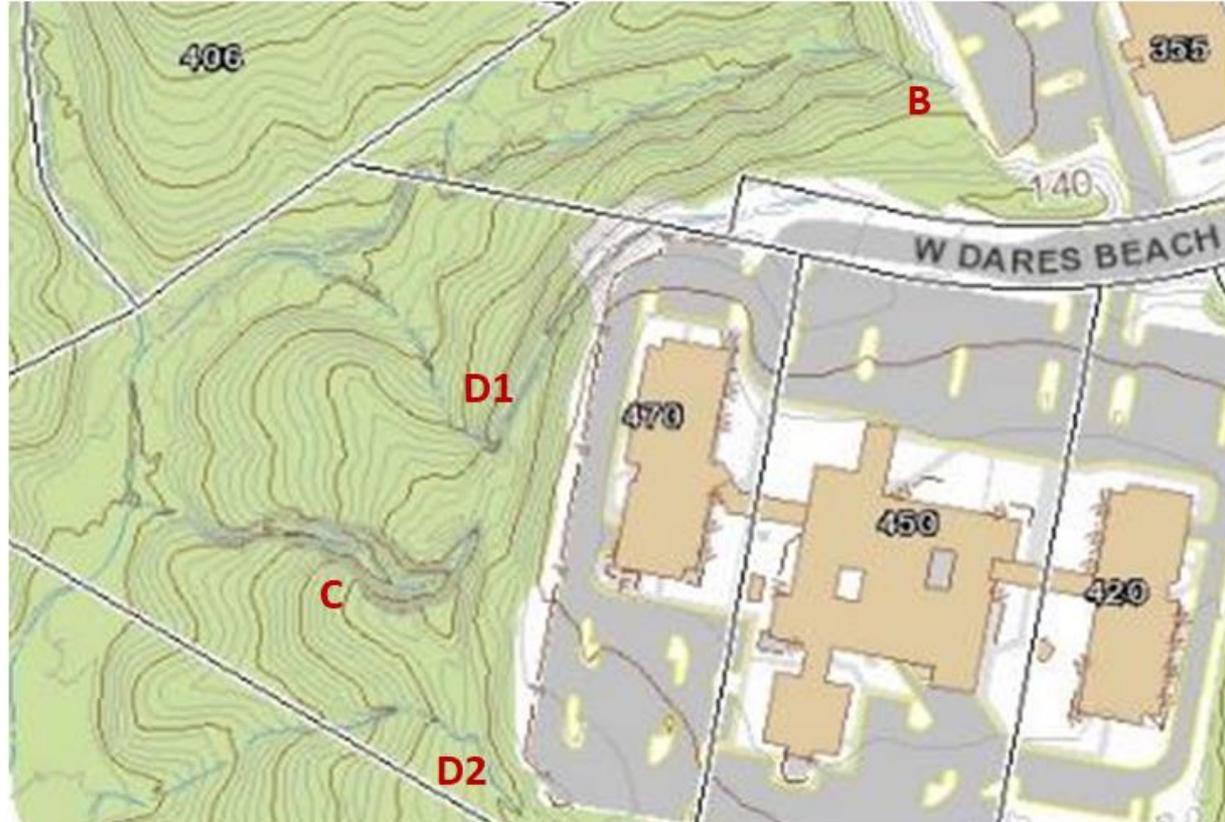
- ARC Has Eroded Head Near Parking Lot

20) I'll not dwell on the ARC site but it also contributes to the sediment deposited into the same Mill Creek tributary. Once again drainage from impervious surfaces was dumped onto a steep fragile slope and severe erosion was the result. Note the rocks in the picture which were no match for the volume of water released. Also note the locations of Senior Center C, D1, and D2.

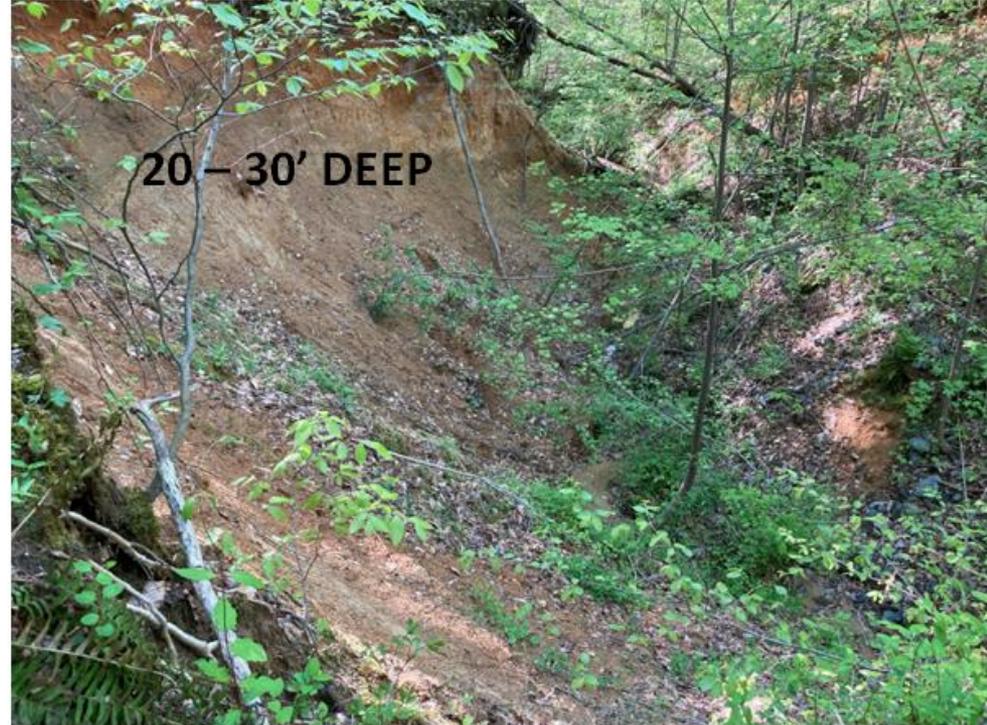
- Built in Early 1990's
- NOT a SWM Facility – Direct Water Away From Buildings
- Severe Erosion Began Shortly After Construction
- Present:
  - Hill cut in half (C)
  - D1, D2 deeply incised side canyons
  - Site plans and grant funding
  - SWM NOT part of rework

21) As I mention before, I will only cover the three ravines near the west side of the Center. The original features for conveying runoff away from the building were built in the early 1990's. The system began failing almost immediately. The result was the 30' deep canyon that cut a hill in half and created two deeply incised side canyons D1 and D2. The pictures of this site as well as others I have shown do not do justice to the damage one sees in person. Public works has \$600,000 in grant money to repair the damage but the repair does not include stormwater management upgrades.

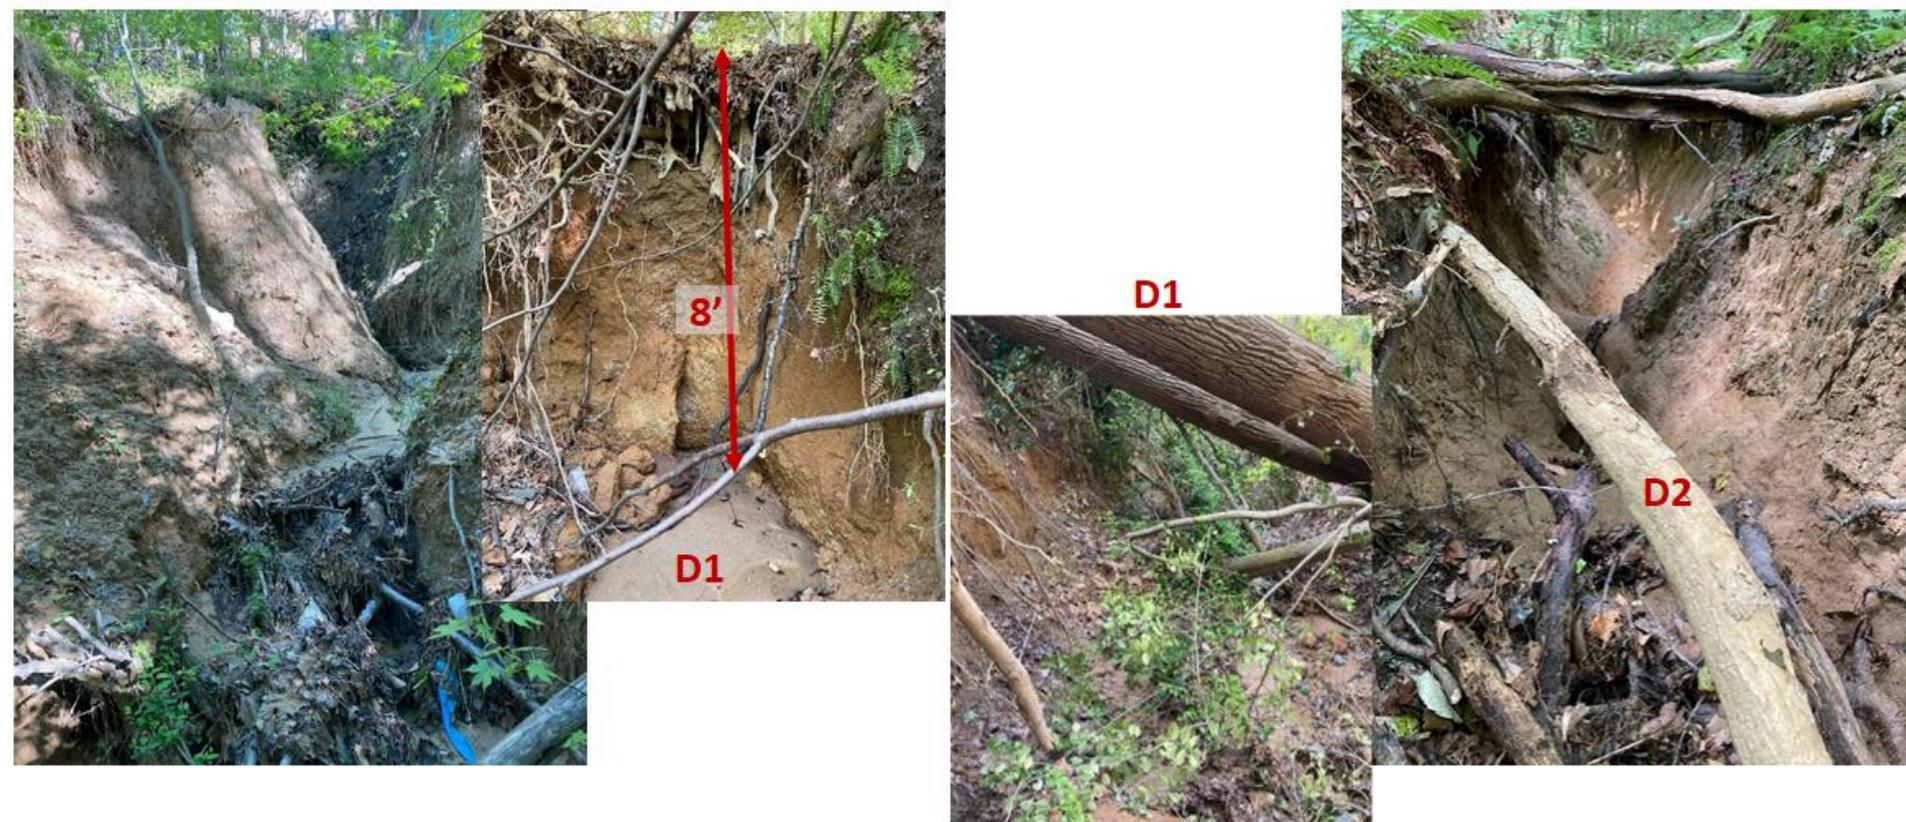
22) These are the two side ravines D1 and D2. They are deep with steep walls and are lined with clay. Oddly, these two side canyons now intercept and divert a majority of the flow that formed the 30' canyon away from the canyon.

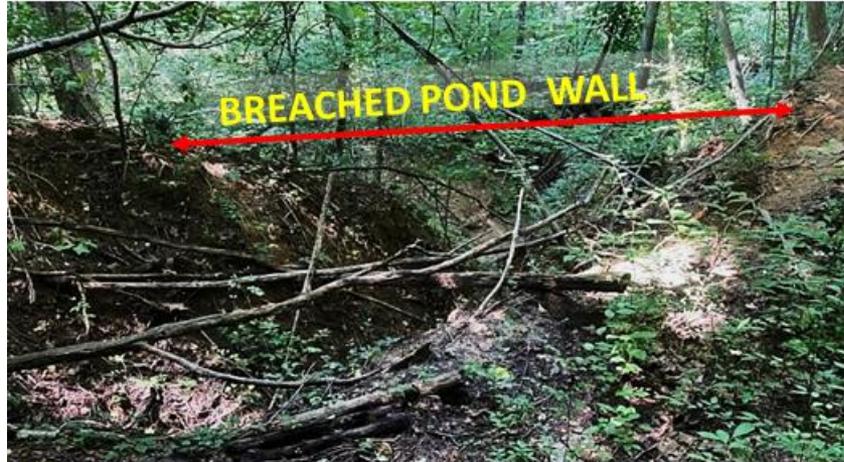
**Ravine entrance into main stream**

24) We see the same sorts of damage as with other sites but the fact that neither the State nor the County will take responsibility for fixing the damage is distressing. The runoff from the State owned parking accounts for much of the damage. Only about a third of the state parking is actually used with the least used parking just uphill from the damaged areas. I would like to see these areas of unused parking turned into viable stormwater management features. What do you think?

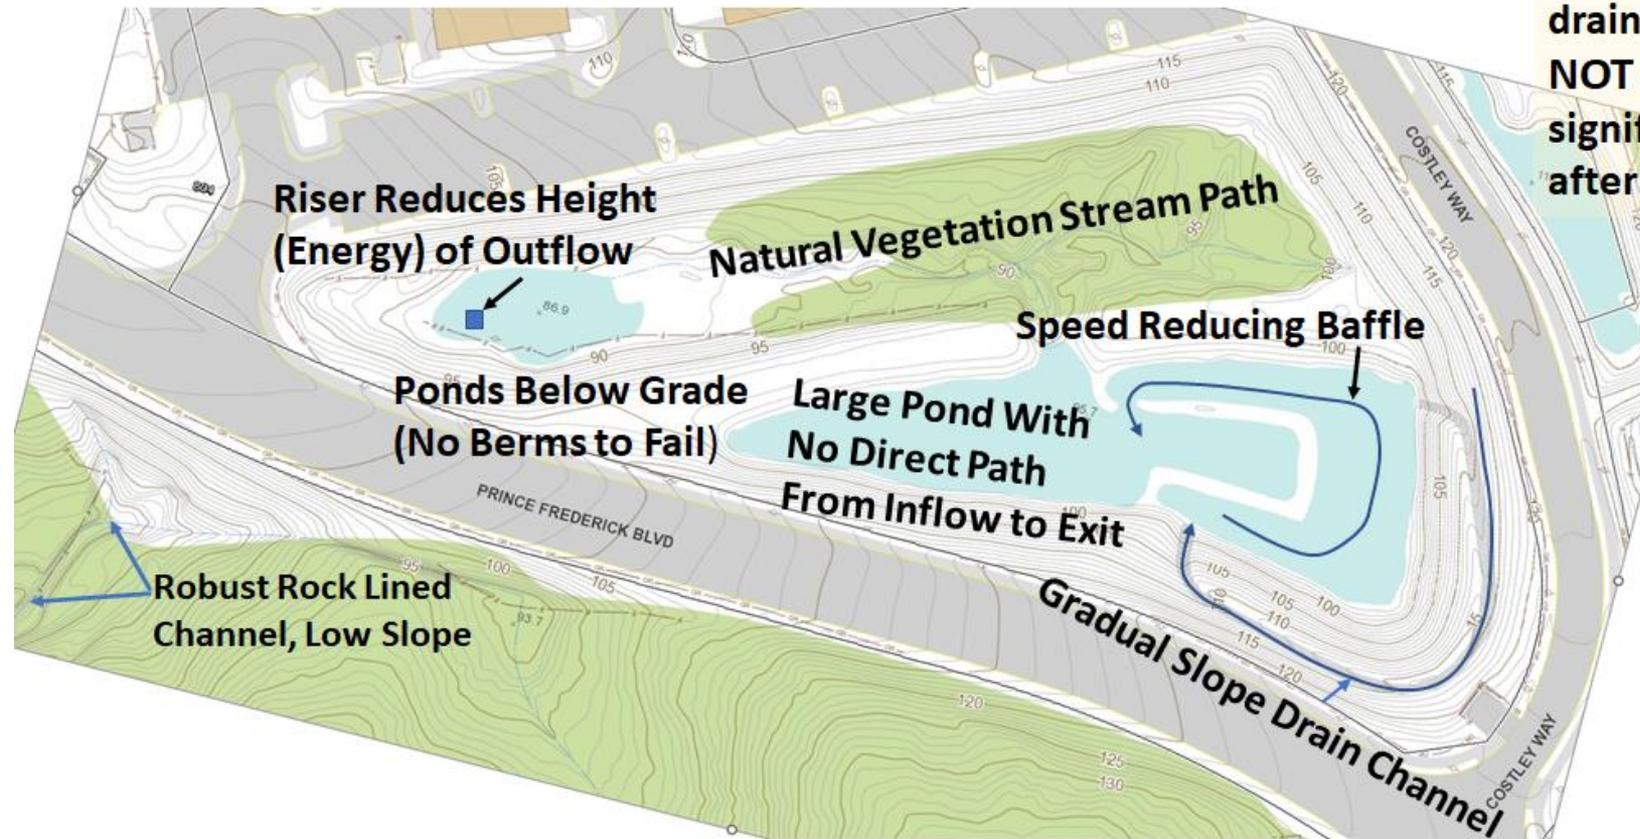
NOTE: The stream that the system drains into did NOT exhibit significant erosion after 9" rainfall.

27) The library system is rare in that even the last hurricane with its 9" rainfall did not damage it nor cause significant downstream damage. I found out in talking with the designer that extra resilient features were built into the design. None of these features are revolutionary on their own but the combination of the features ensured success even when faced with an extreme event. Pull over some time and take a look. I especially like the baffle and the gradual slope drain channel.
