Slope Evolution Study

Presentation

Curt Larsen

So You'd Like to Stop Shore Erosion along the Calvert Cliffs. You'd better think before you act.

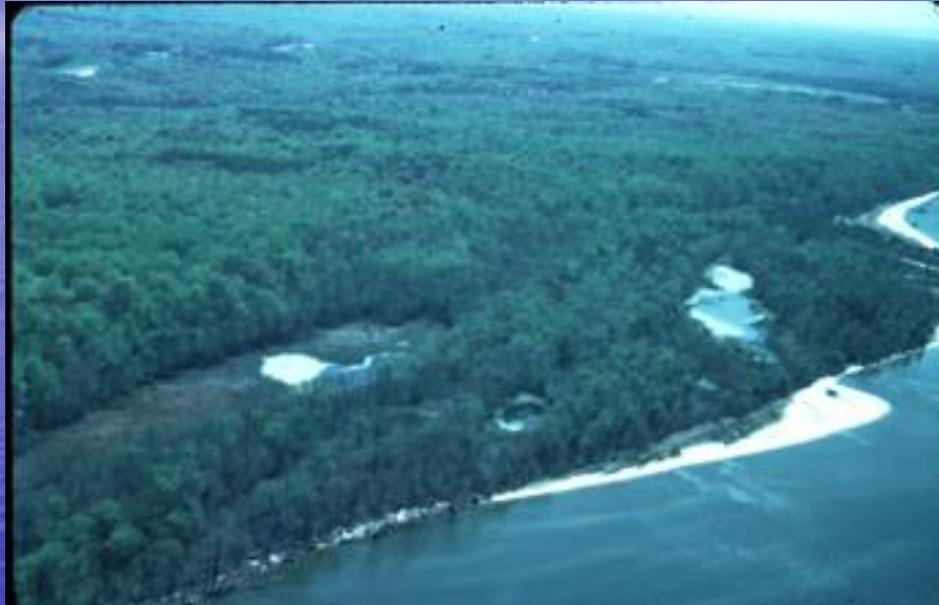
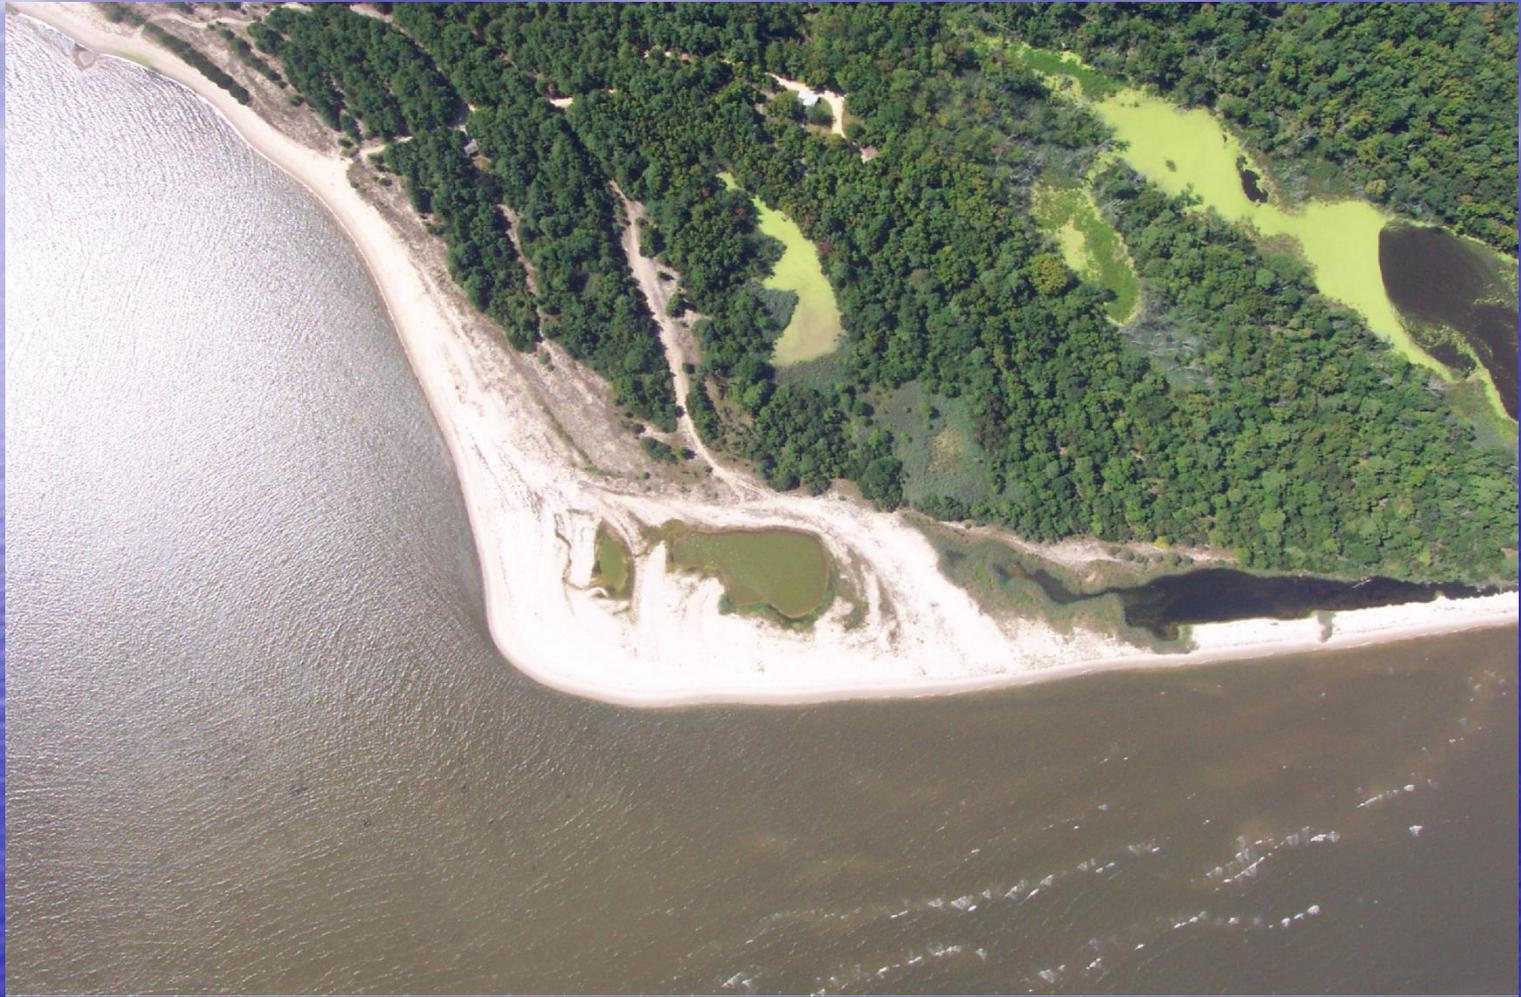
Flag Ponds Nature Area.

Flag Ponds is a series of sand spits deposited southward along the western side of the Bay derived from sediment from eroding bluffs to the north. These spits progressively protected bluffs from wave attack as well. It provided a second "fossil bluff" line for measuring the rate of change in slopes. Pollen studies of sediments overlying the formerly active beach deposits at the base of the fossil bluff contained Ragweed pollen. This pollen is a time marker for the beginning of European settlement in the area. Hence, these spits were at most 400 years old.

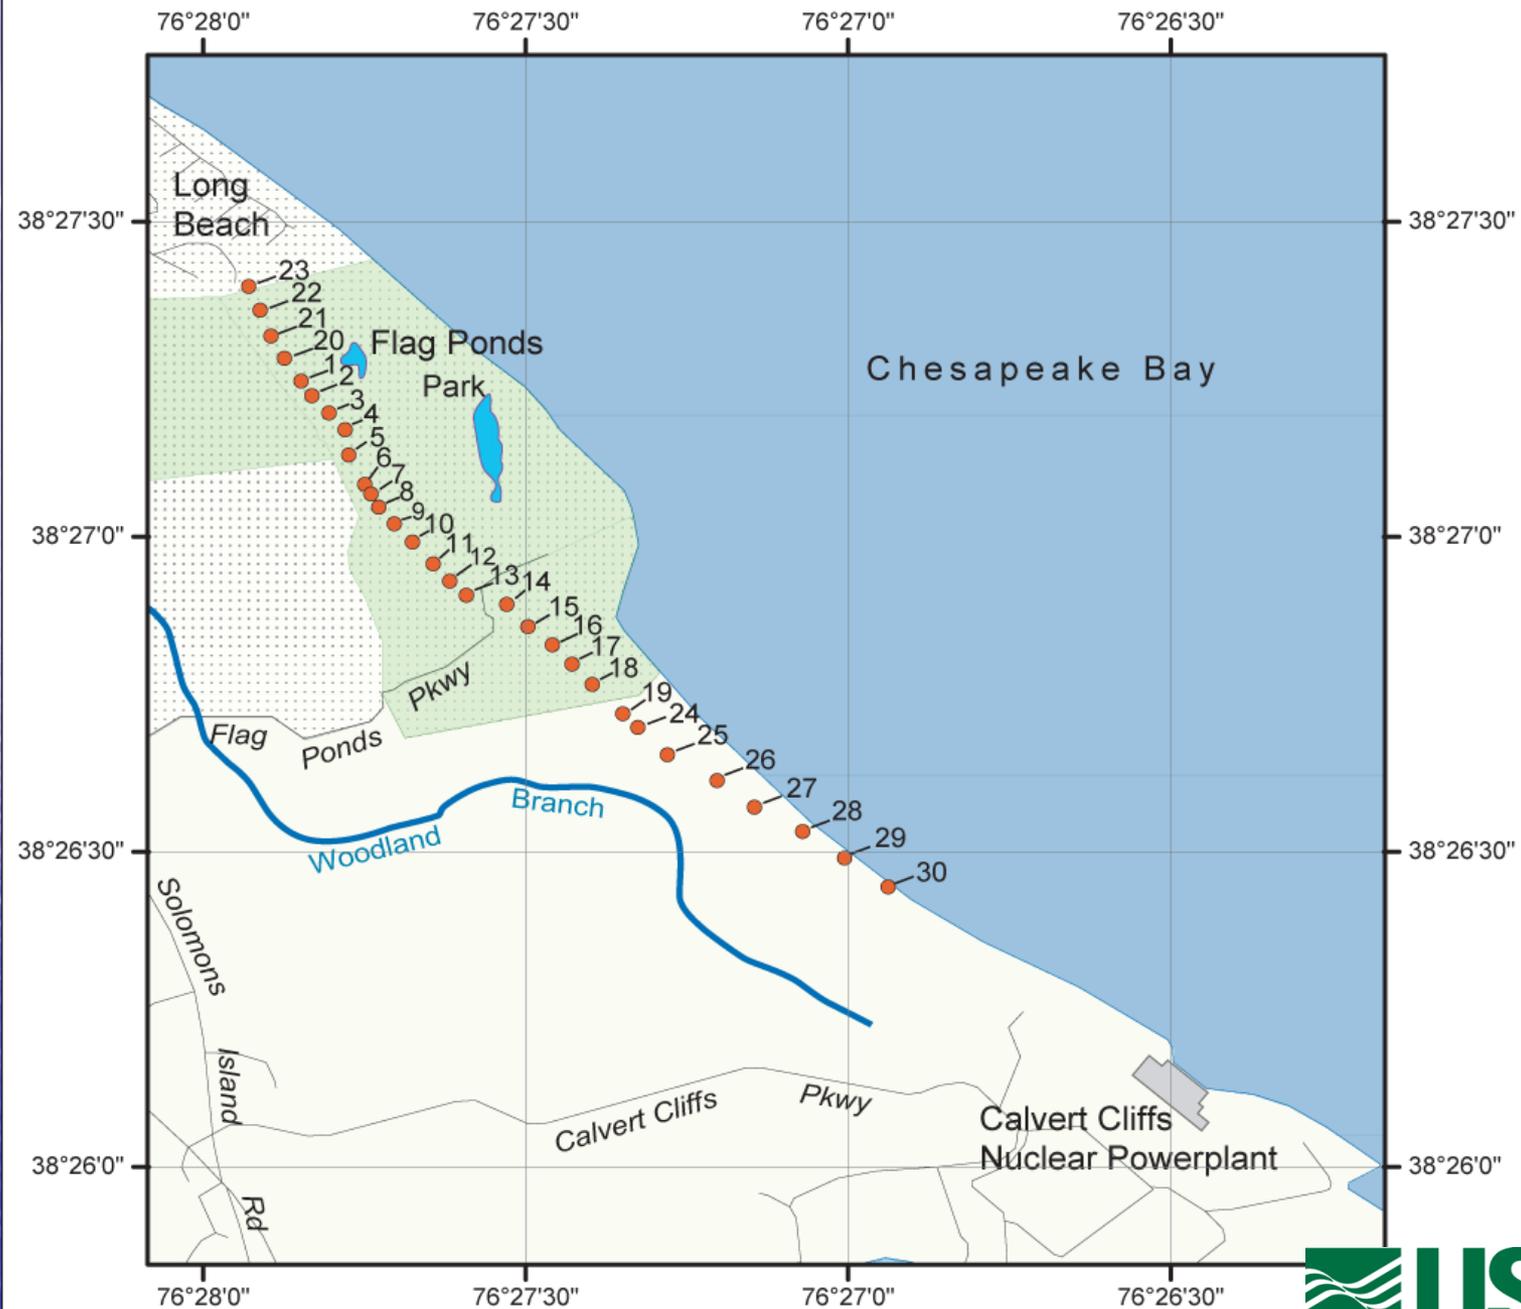
Slope Angles were again
Measured.

Here again all protected slopes had failed and evolved into stable slopes with a mean slope angle of 35 degrees and
Within a time frame of 400 years! Clearly this was a rapid process!

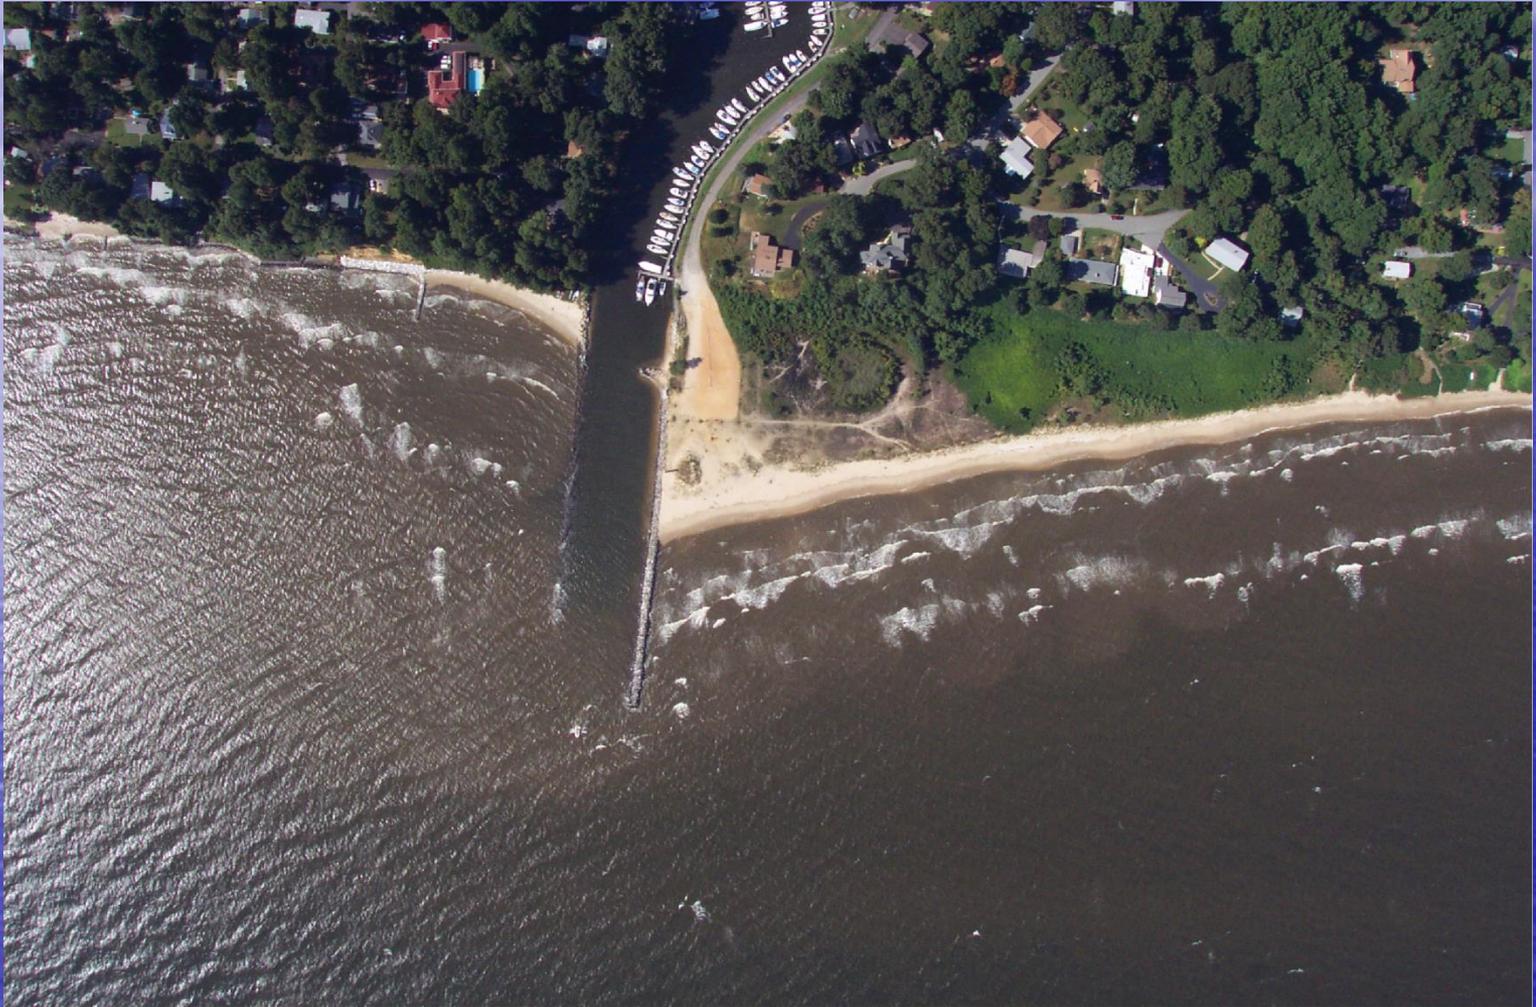
Flag Harbor provided an accurate key to understand the process of slope evolution. The harbor had been created by dredging a channel to link a ravine eroded in the bluffs to establish a marina. The entrance to this channel was then protected by harbor jetties in 1947 to maintain the channel entrance. The northern jetty progressively trapped sediment moving southward along the shore.

For our study, this provided progressive south to north protection of a very young "fossil bluff" behind this wedge of sediment.

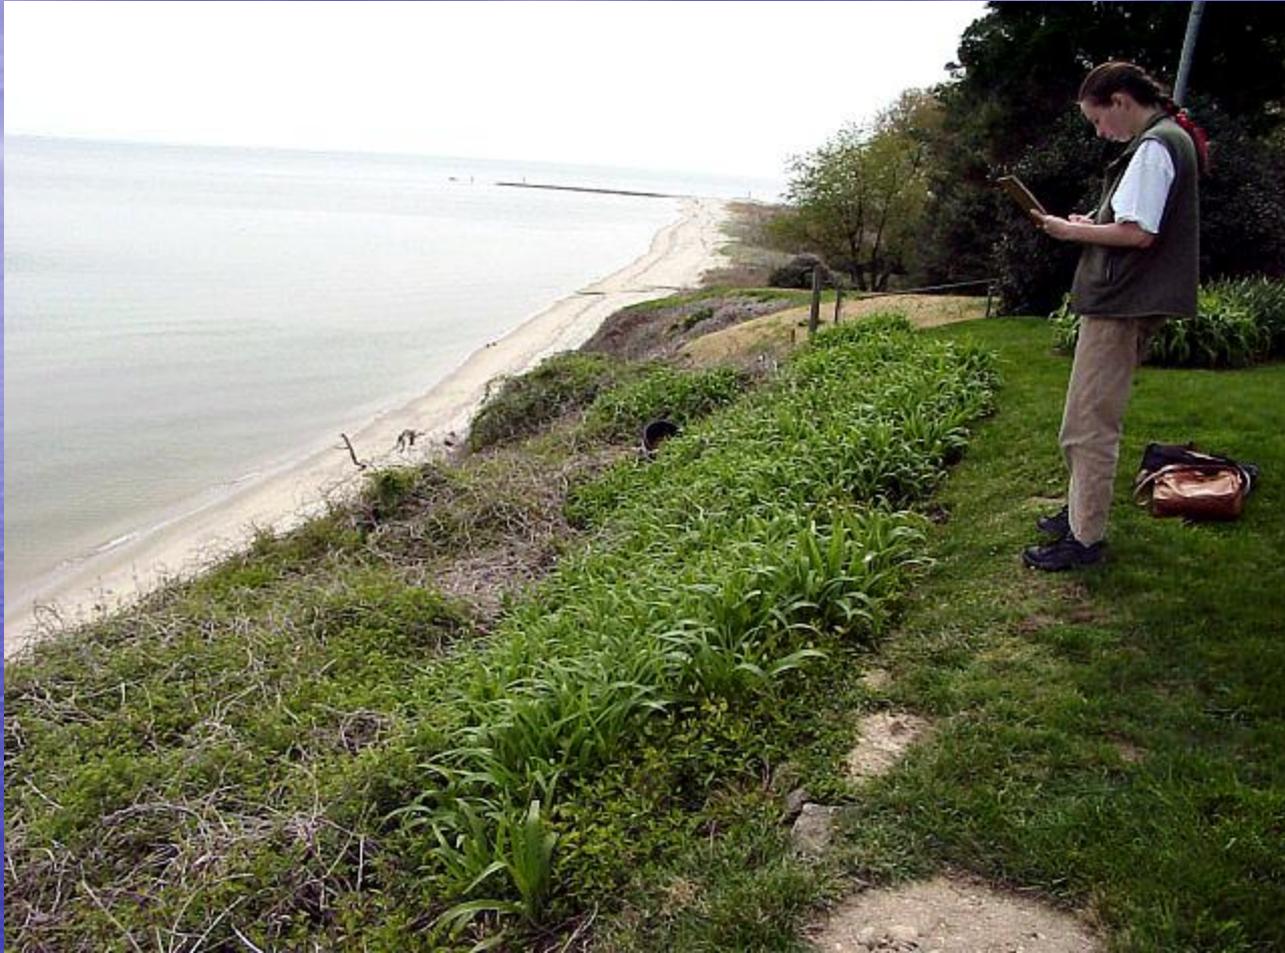
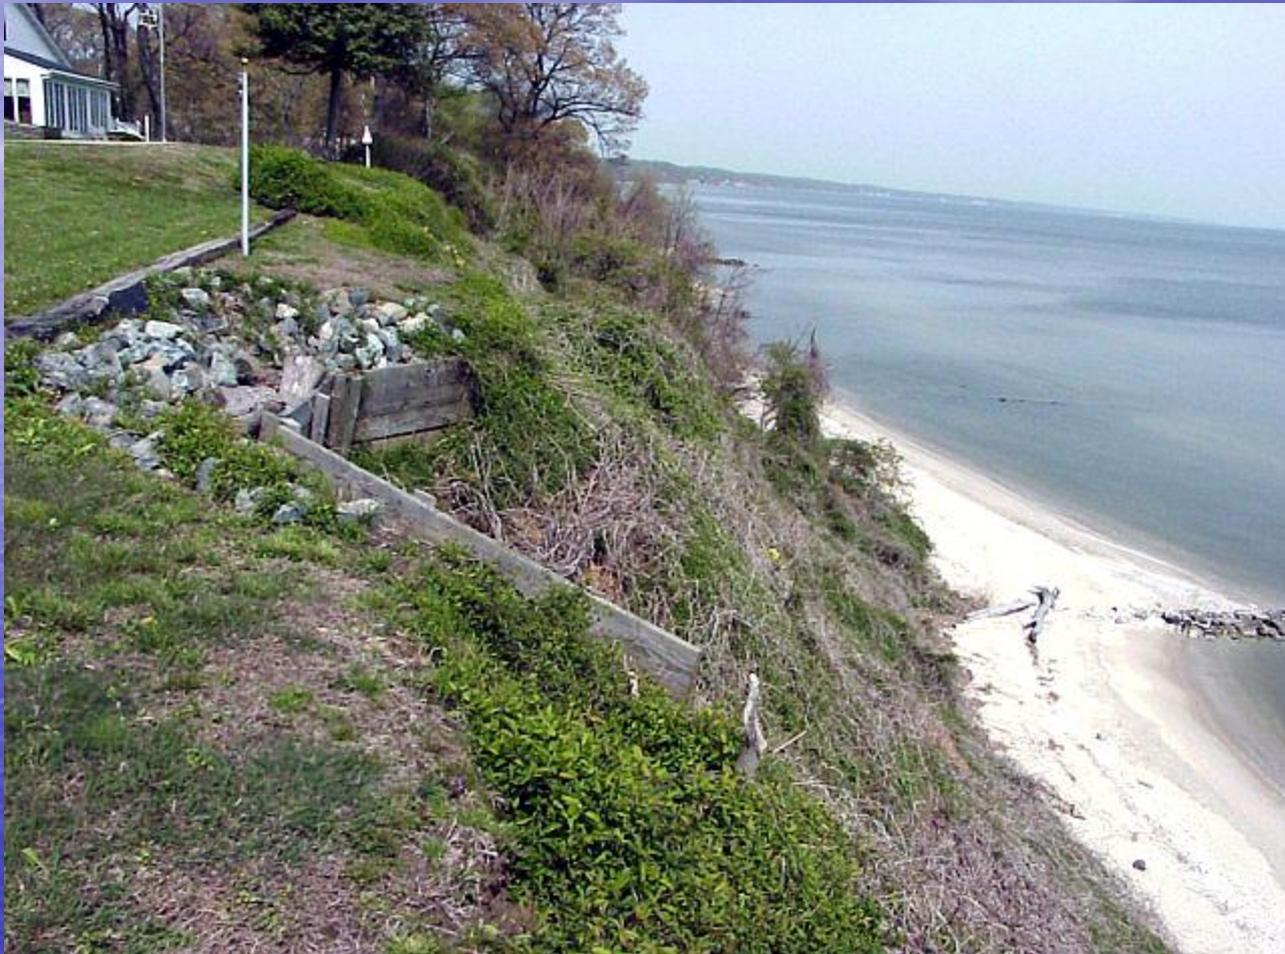
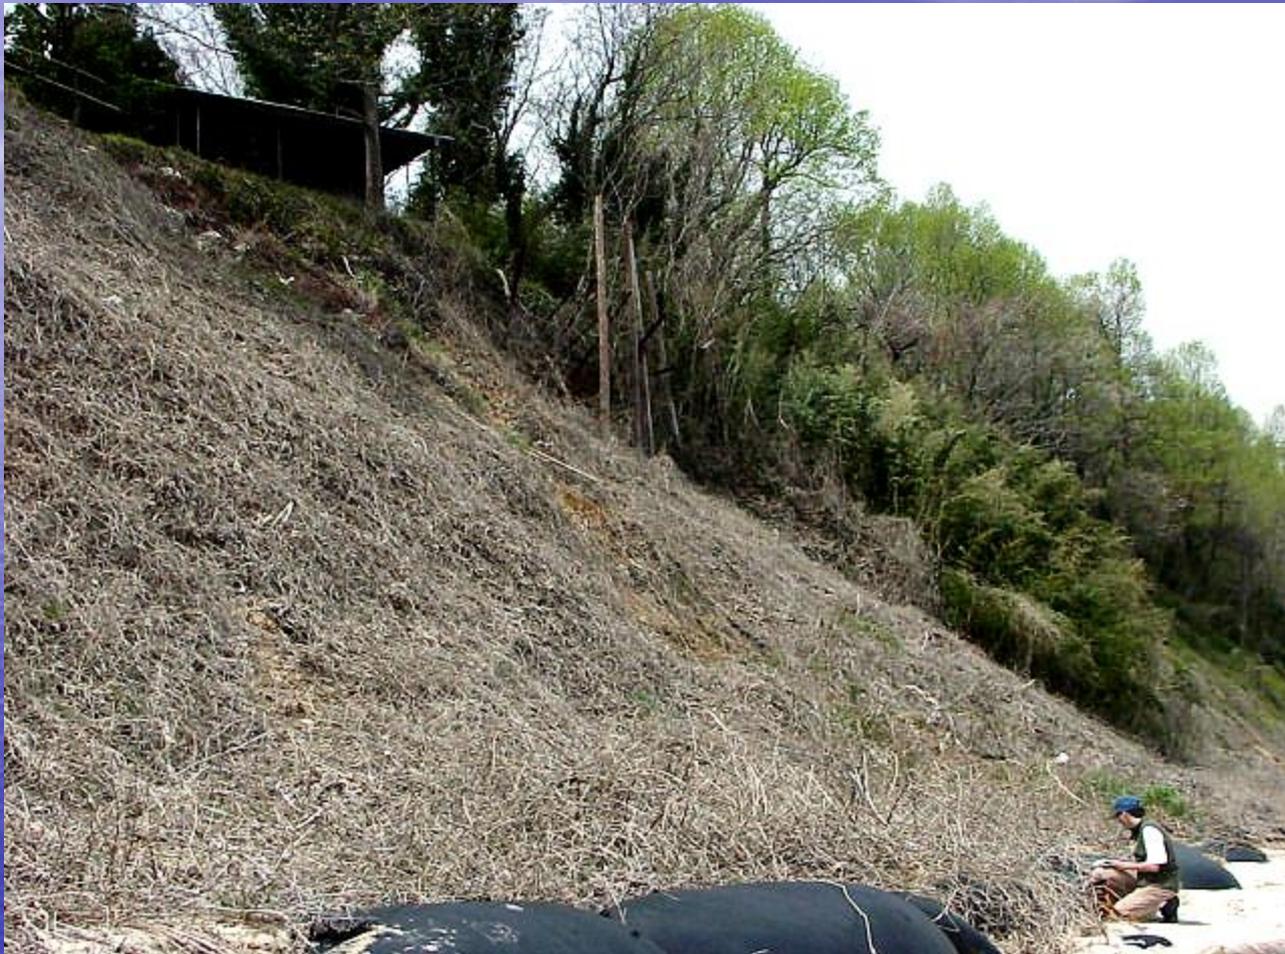
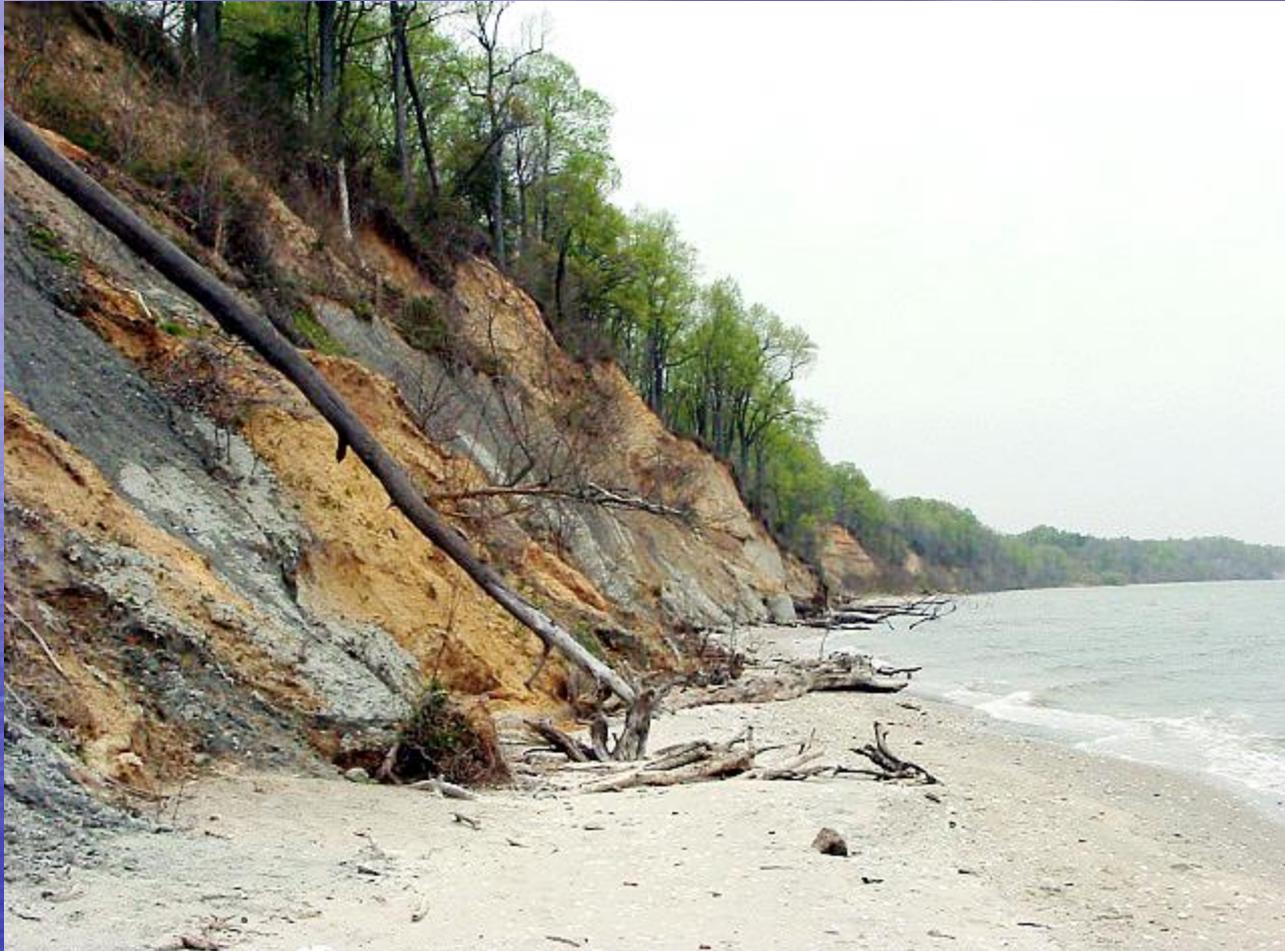
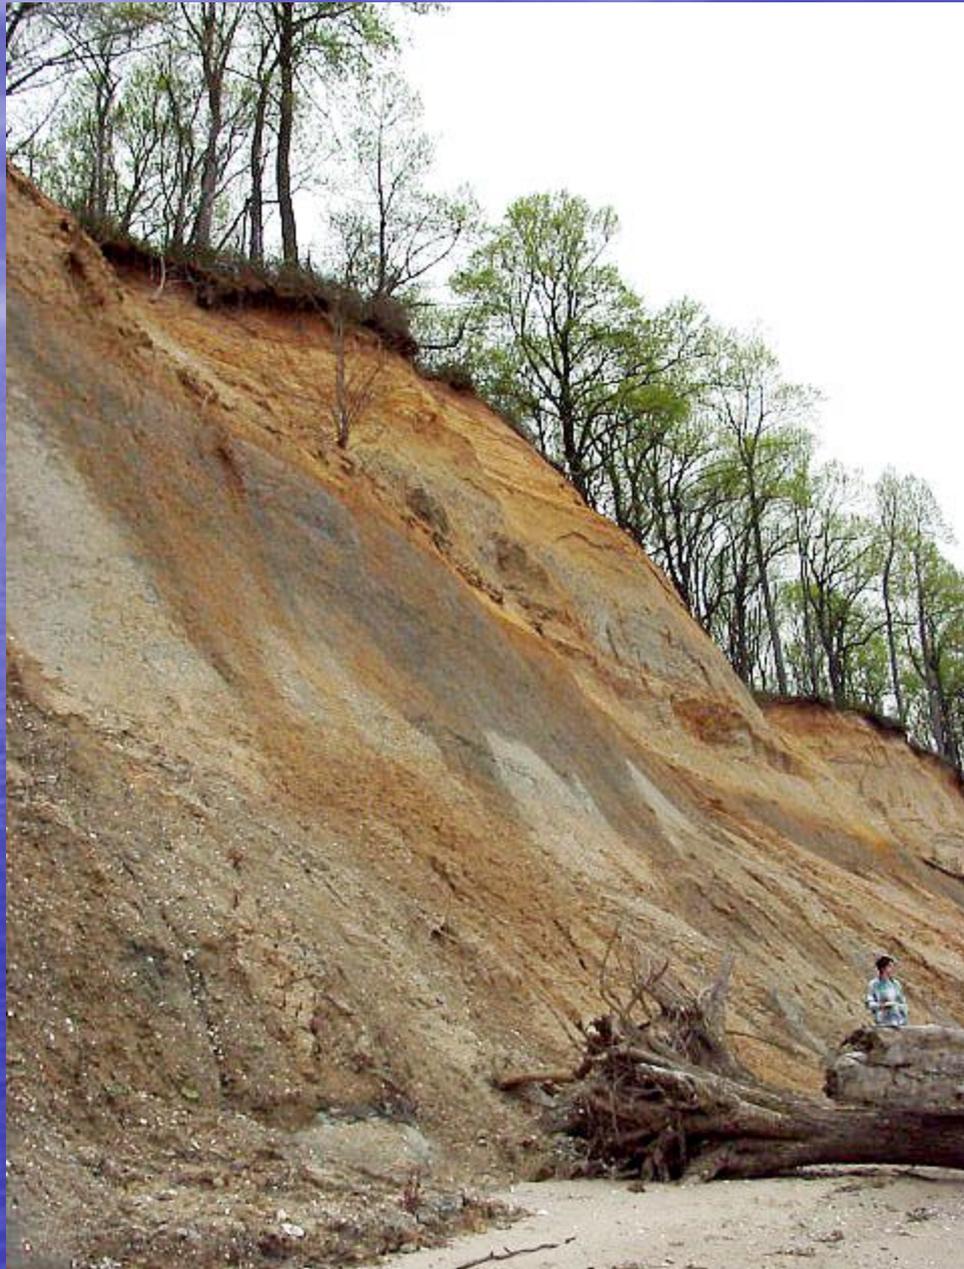
Photos showing a south to
north progression in slopes.

To the north the progressive change from active wave action and bluff-sloughing to slope retreat through bluff top failure was documented. Once artificially protected, the slope angles changed from 70 degree to 45 degree slopes in 25 years!!

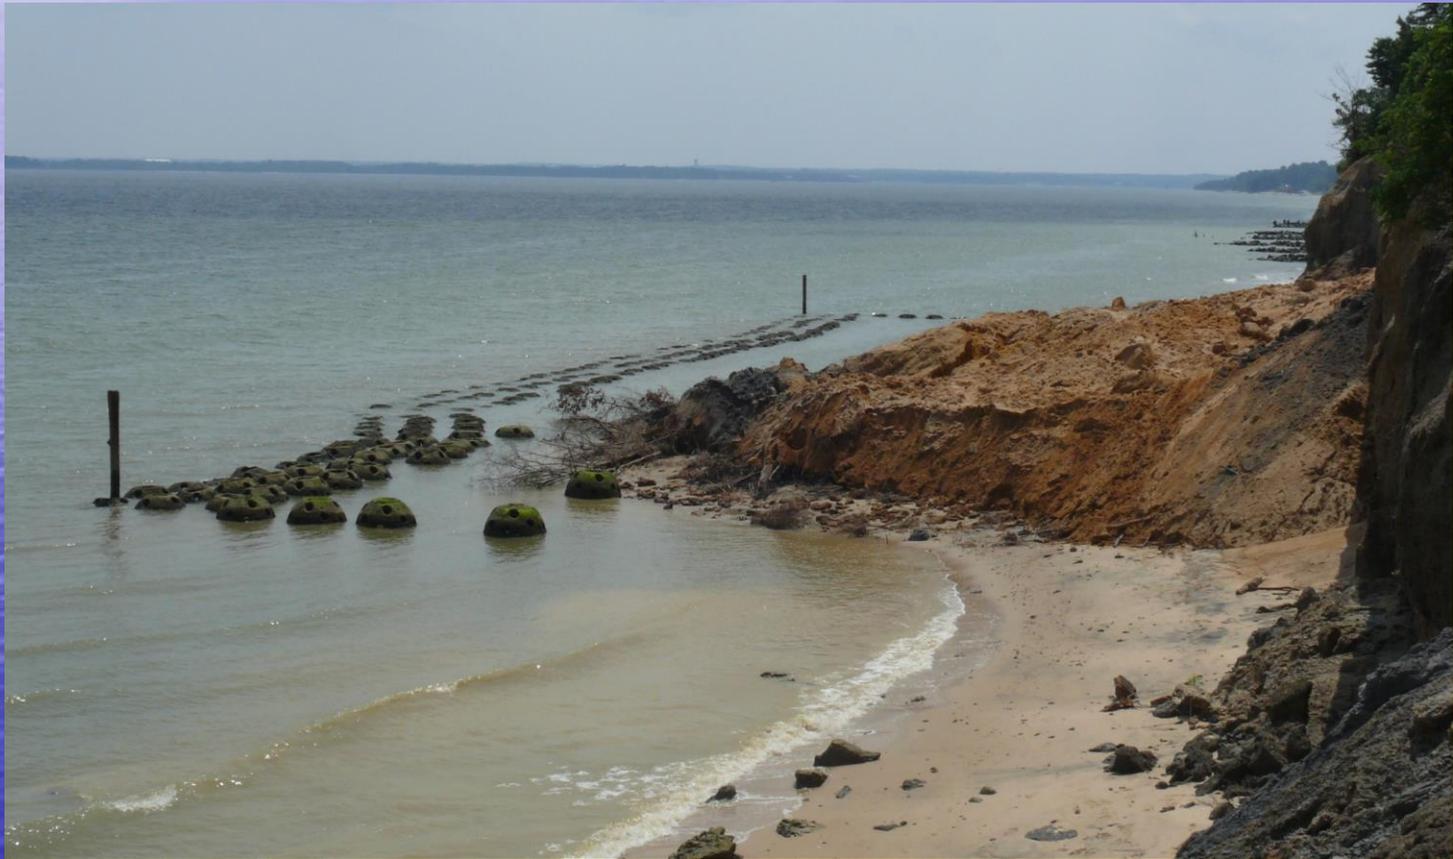
Close Up off Slide with protection
