# Stormwater Management Successes and Failures in the Prince Frederick Area

Presented to Calvert County Environmental Commission  
April 24, 2023

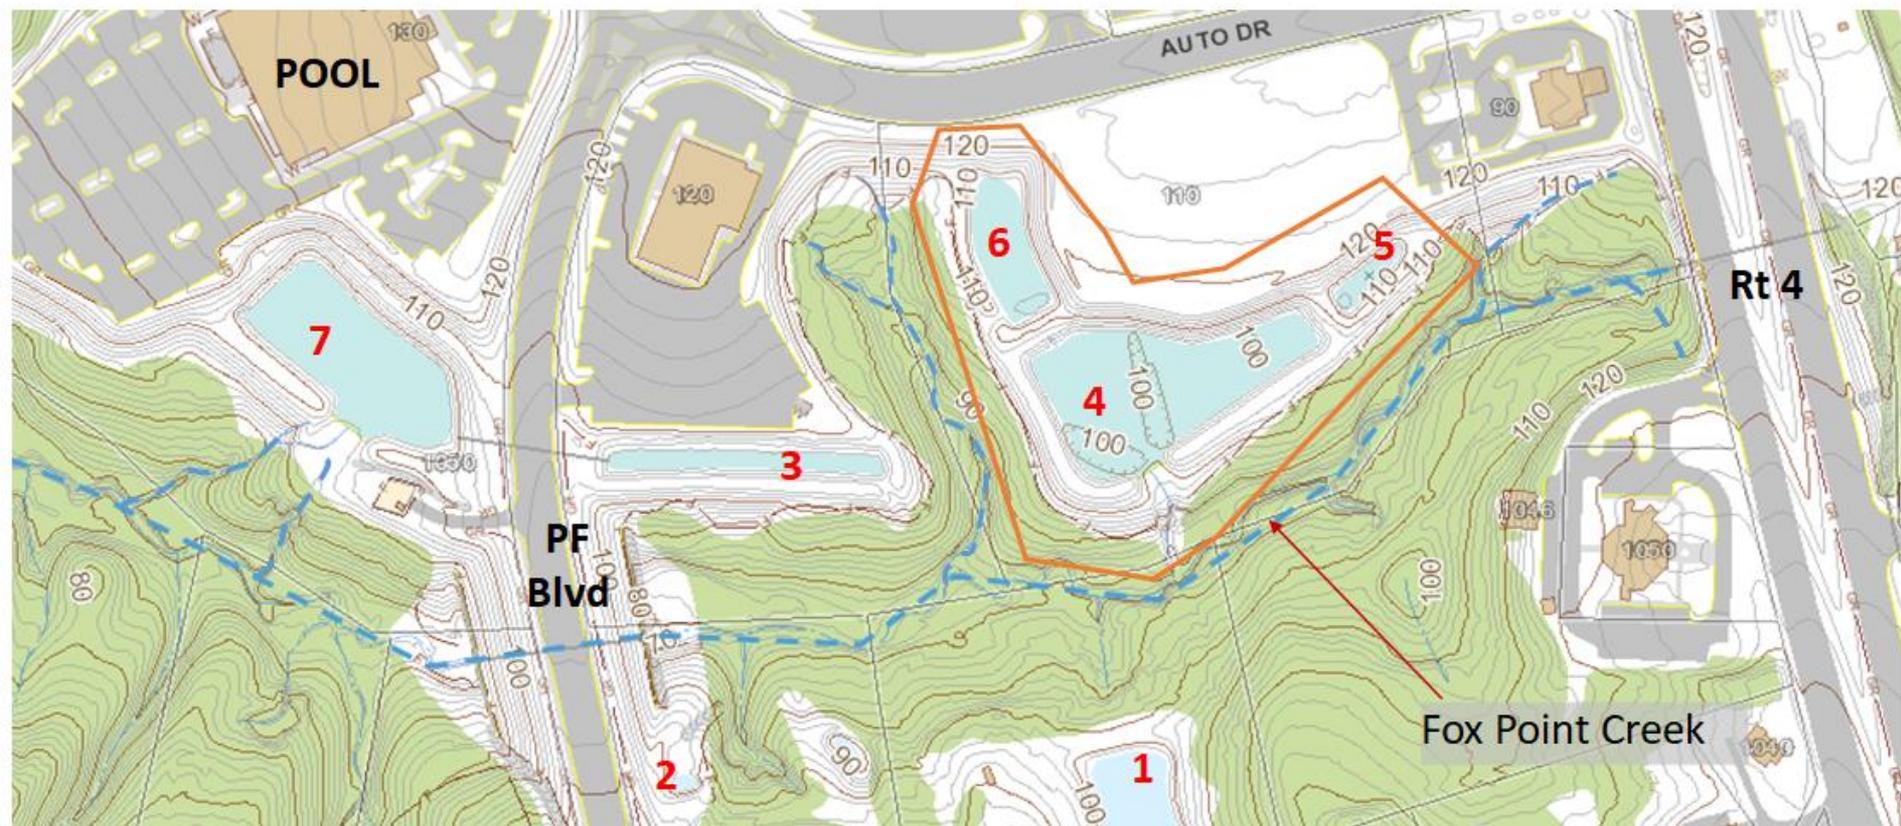
#4 System (incl ponds 4, 5, 6) = "Auto Drive"

#7 = "Pool"

8) The first area is in the headwater of Fox Point Creek close to the Aquatic Center. On the map you can see the pool, Prince Frederick Boulevard, and Rt4. We'll first look at the #4 system seen outlined in orange. The outflow of Pond 4 flowing down to the creek is the focus. Note the steep slopes leading to Fox Point Creek.

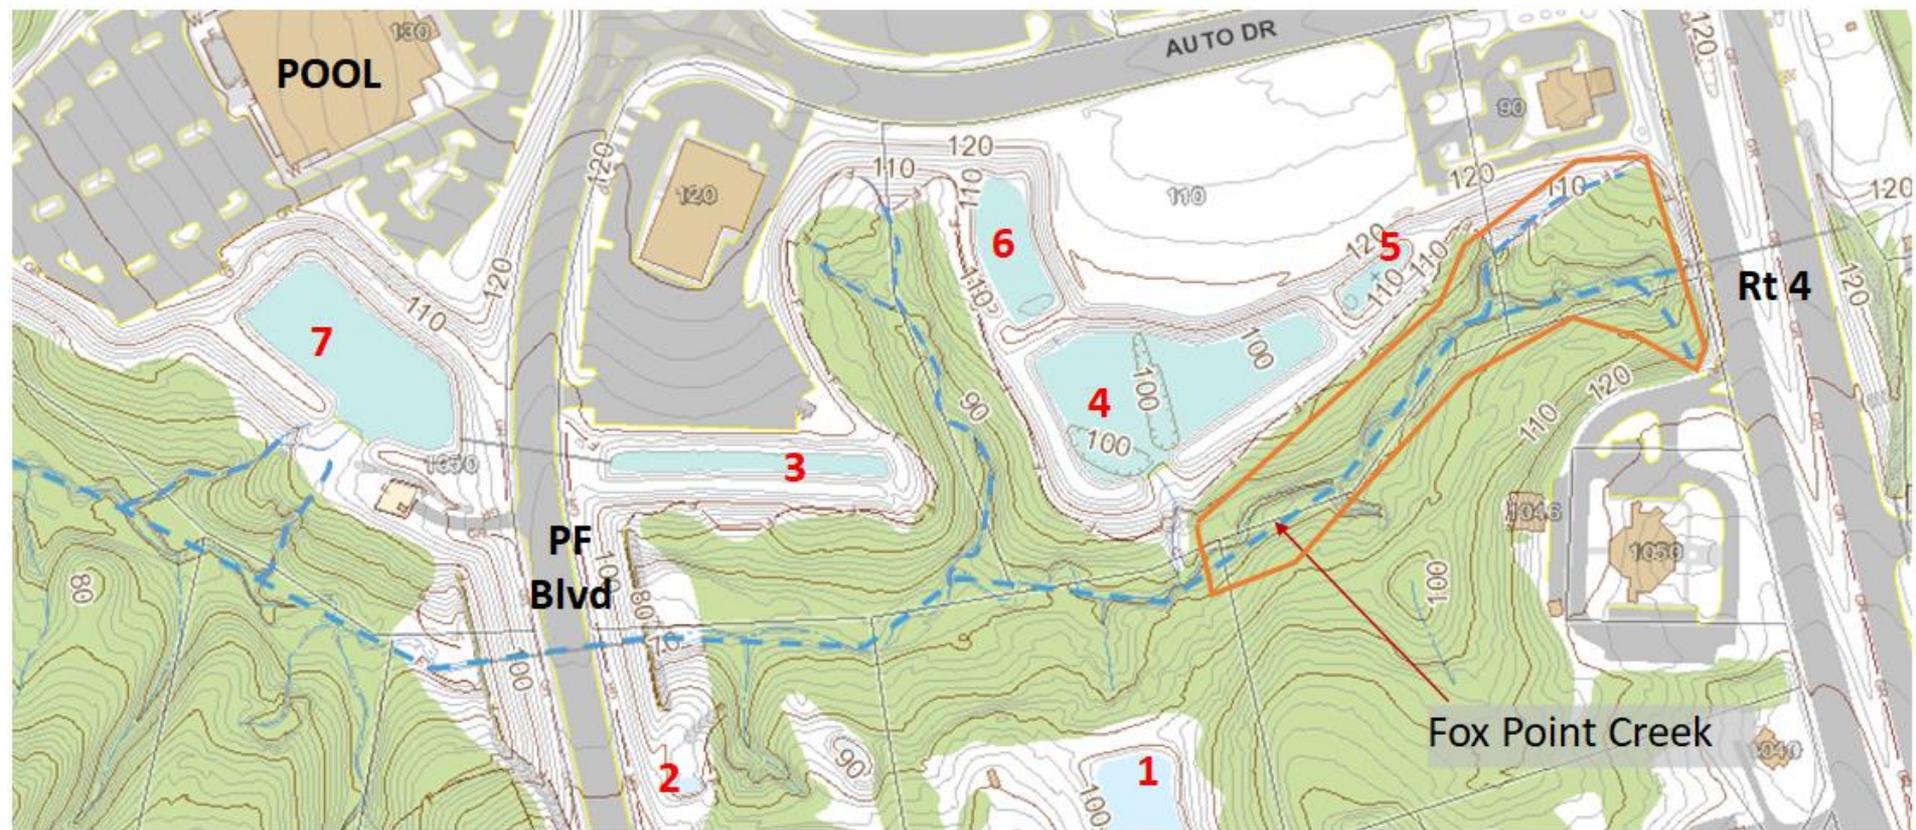
#4 System (incl ponds 4, 5, 6) = "Auto Drive"

#7 = "Pool"

10) Next, we'll look at some pictures of the creek just upstream of Pond 4's outflow.

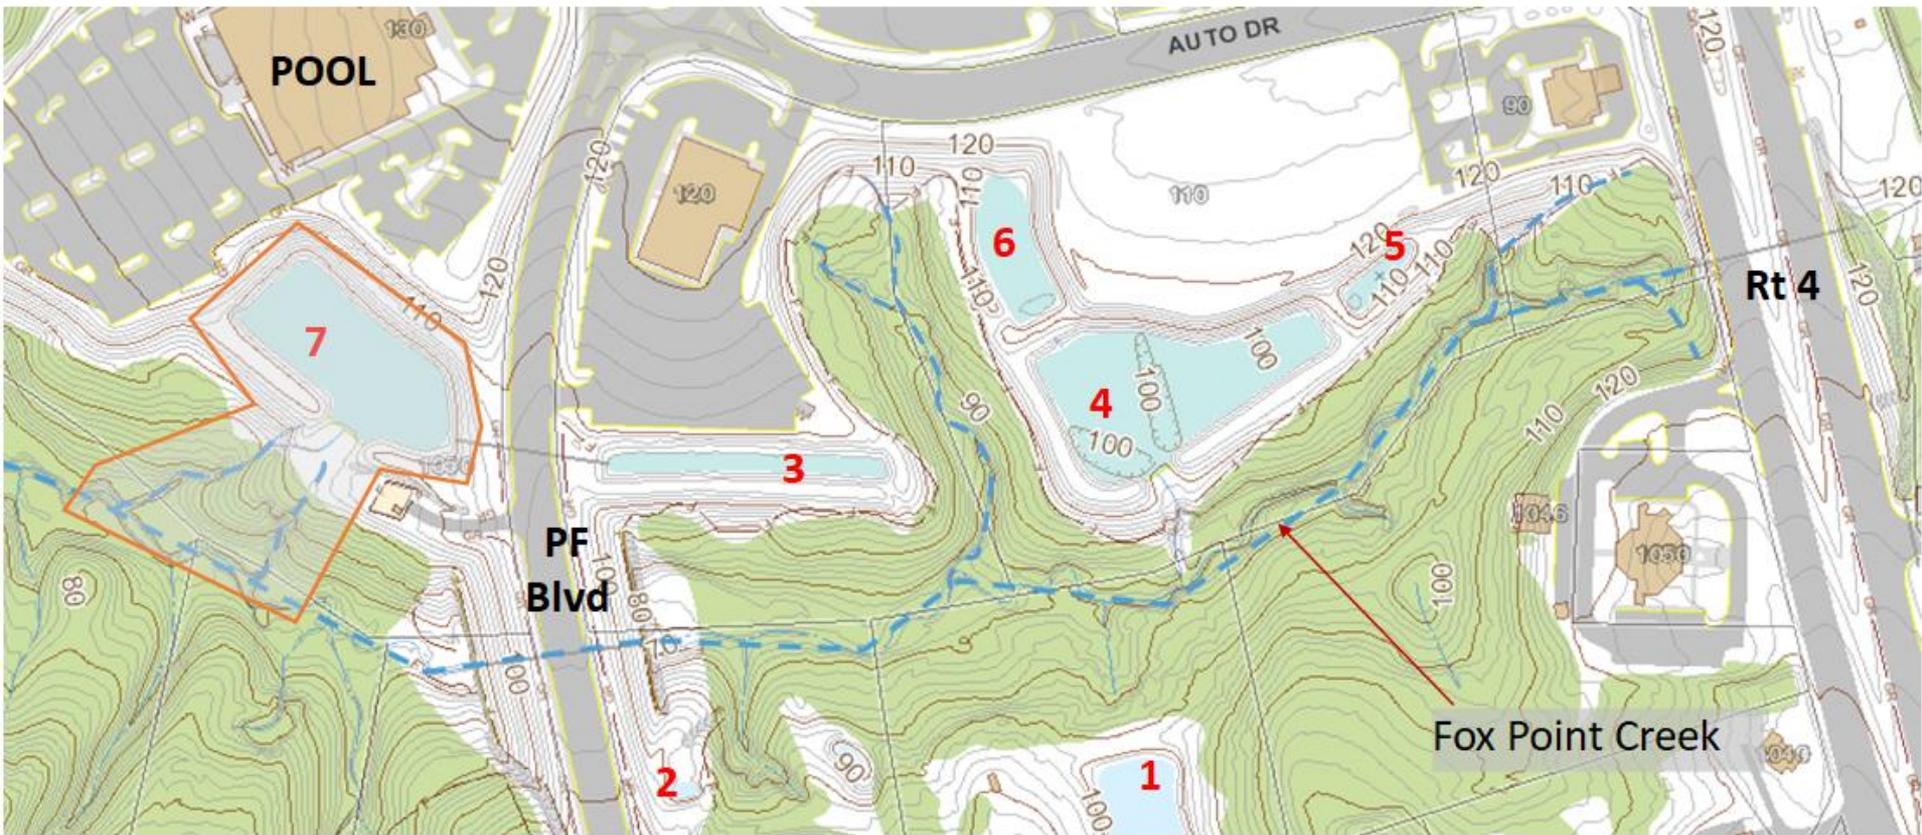
#4 System (incl ponds 4, 5, 6) = "Auto Drive"

#7 = "Pool"

12) Last for this area is the outflow from the pool's stormwater pond as seen by the orange outline. Again, note the steep slope between the pond and the creek.

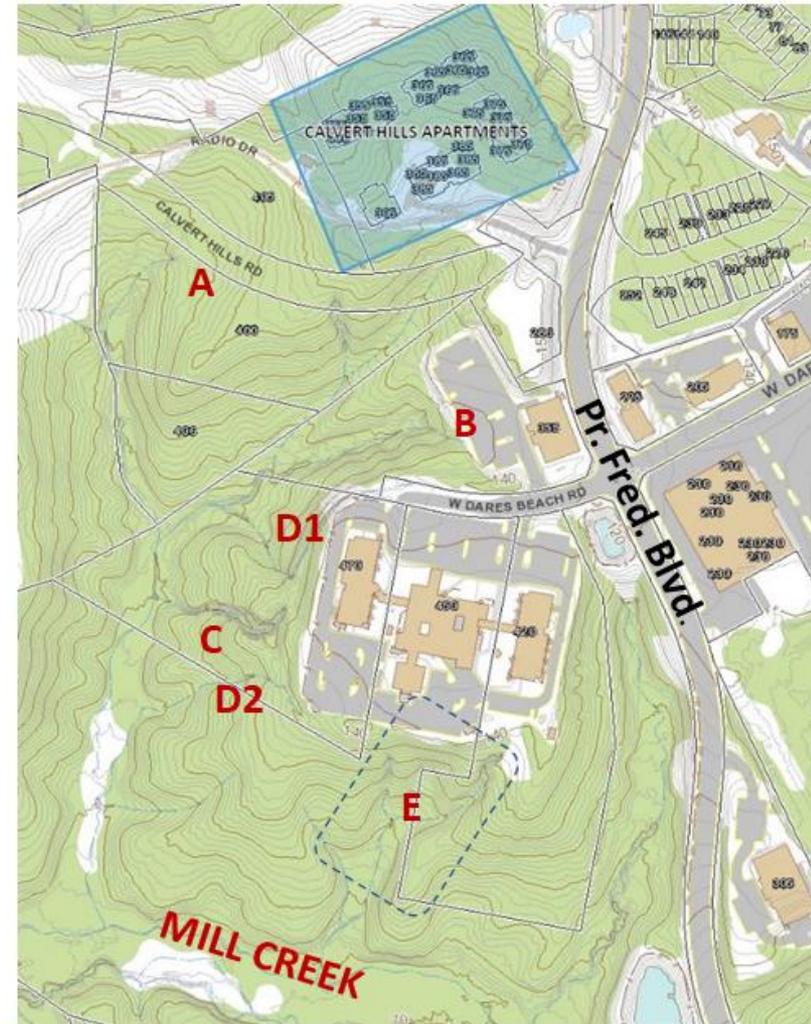
- **A = Calvert Hills Apartments**
- **B = ARC Parking Drainage**
- **C = Senior Center, Main Ravine**
- **D = Senior Center Secondary Ravines**
- **E = Senior Center, Area B**
  - Not covered in presentation
  - Eroded ravines
  - Destroyed silt fencing
  - Significant sediment conveyance
  - Included in proposed remediation

15) Next, we'll go to another region I call South Prince Frederick Boulevard. We will look at the Calvert Hills Apartments just north of Dares Beach Road, the damage downhill of the ARC parking lot and the undeveloped area around the Calvert Pines senior center. There are three ravines on the west side of the Senior Center which I have labeled C, D1 and D2. I will not present Site E but it features eroded ravines and destroyed super silt fences. It empties into a Mill Creek floodplain.

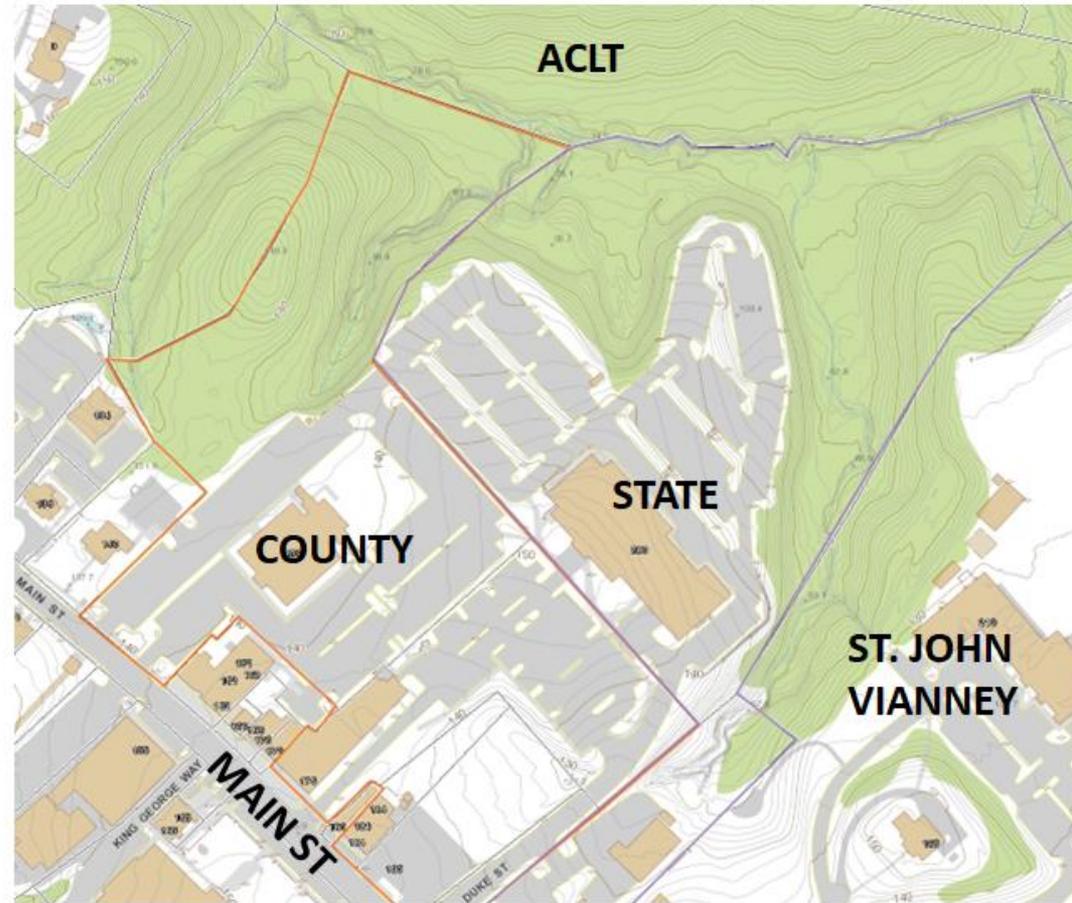
- State and County Facilities
- Each Have Contributed to Significant Erosion and Sediment Production and Transport
- Old Designs (dump over the side of the hill)
- Little or No Maintenance or Repair

23) Now onto my last failure site located at the government plaza in downtown Prince Frederick. The land downhill of the parking lots is steep and fragile. It is owned by a combination of the State, the County and a small part by St. John Vianney. The drainage off of the parking lots is essentially just dumped over the hill. The result is again spectacular eroded features and destruction of the minimal stormwater management features employed. The flow off of the plaza makes its way into Parkers Creek and then into the Bay. As with many of the failed systems there is little maintenance provided and no plans for remediation.
